# Service Bulletin

Bulletin No.: 24-NA-016

**Subject:** Malfunction Indicator Lamp Illuminated in the Driver Information Center and DTC C053E

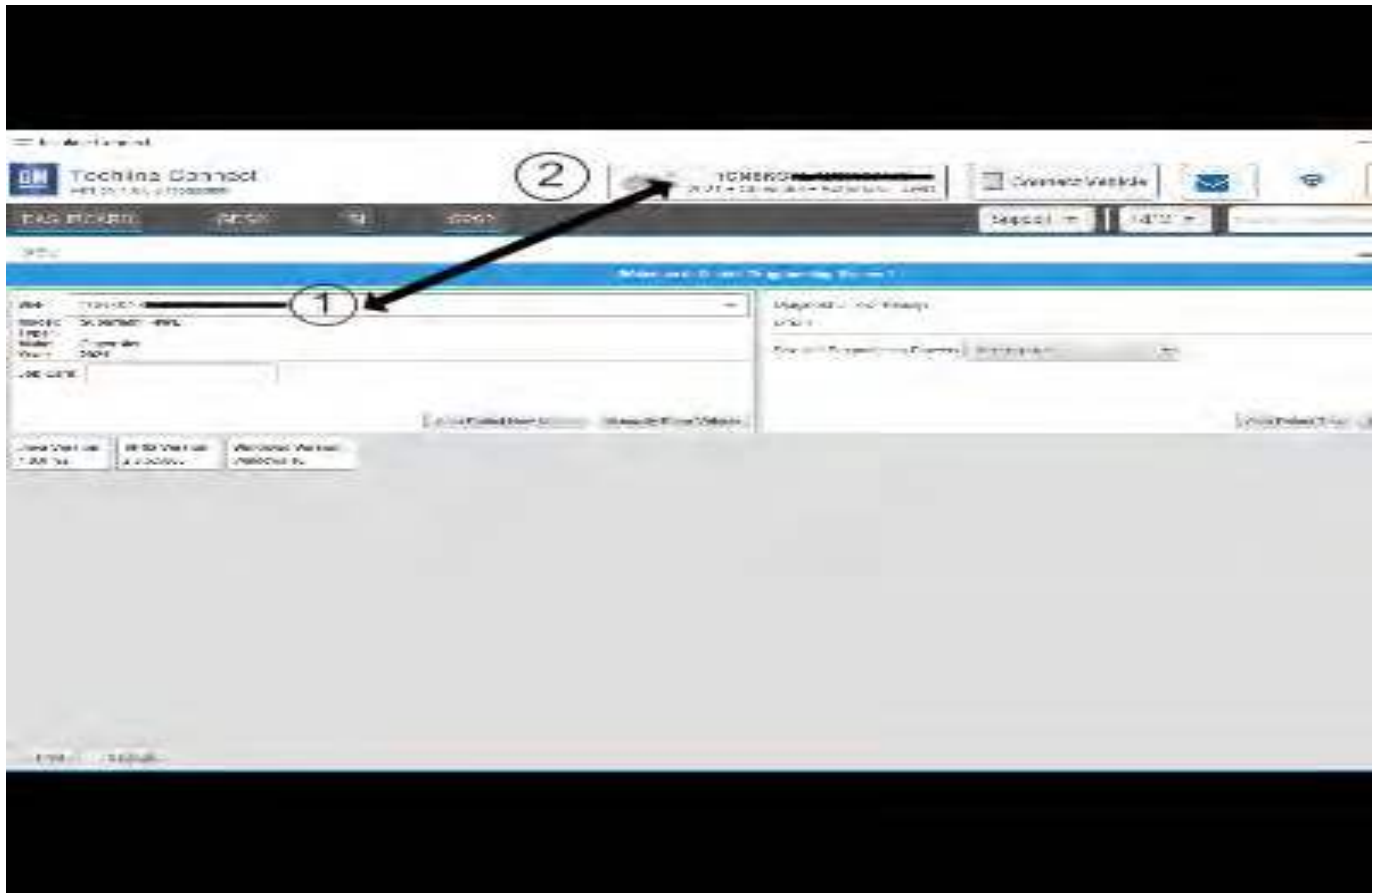
Caution: Be sure the VIN selected in the drop down menu (1) is the same as the vehicle connected (2) before beginning programming.

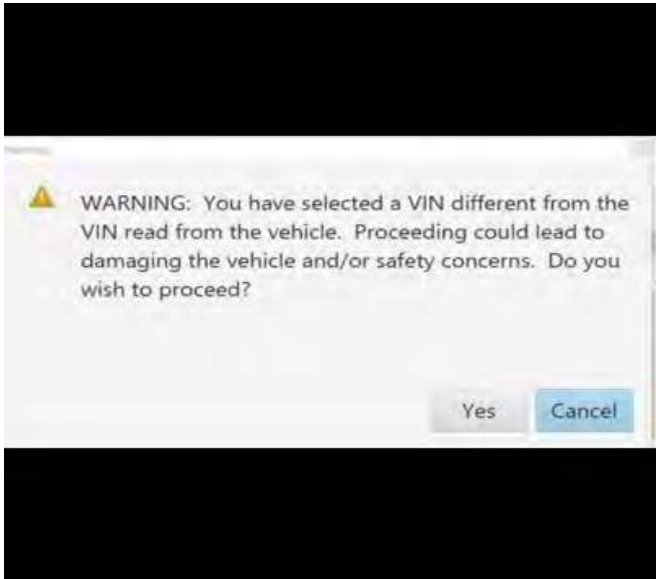
5877000

Important: If the vehicle VIN DOES NOT match, the message below will be shown
