2022-2024MY  
Carnival (KA4)

062 (Rev 1, 03/22/2024)

SERVICE ACTION: ECM LOGIC UPDATE FOR DTC P2118  
AND THROTTLE BODY FREEZING (SA514)

This bulletin provides the procedure to update the software logic of the Engine Control Module (ECM) system on some 2022-2024MY Carnival (KA4) vehicles produced from January 4, 2021 through November 6, 2023, which may exhibit an MIL "ON" with DTC P2118. The throttle body plate may freeze after a cold soak in very cold temperatures, possibly causing the vehicle to go into "limp-home" mode. Once the vehicle is warmed up, the throttle body performs normally. Follow the procedure outlined in this publication to apply the improved logic to the 'Engine' system using the KDS ECU Upgrade function as described in this bulletin. For confirmation that the latest reflash has been applied to a vehicle you are working on, verify the ROM ID using the table on pages 3-5 of this bulletin. Before conducting the procedure, verify that the vehicle is included in the list of affected VINs.

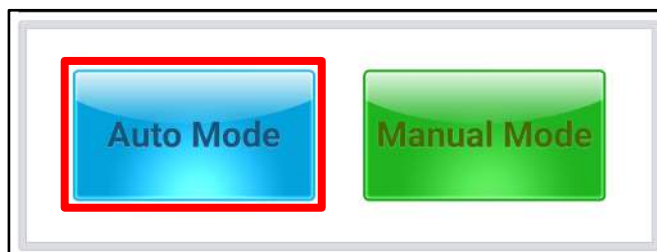
6. Select Auto Mode.

Do NOT attempt to perform a Manual Mode upgrade UNLESS Auto Mode fails. Always follow the instructions given on the KDS in either Auto or Manual mode.
