| <b>Subject:</b><br><br>"TELEMATICS MALFUNCTION" MESSAGE WITH DTC U3000:04-TCU | <b>Bulletin No.:</b> 09-001/24 |
| | <b>Last Issued :</b> 03/14/2024 |

**DESCRIPTION**

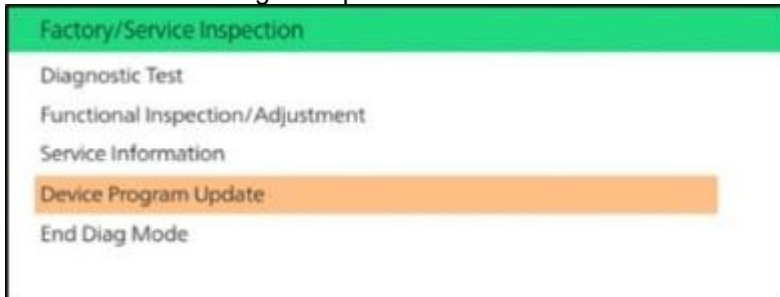
h. Select "Device Program Update" on the screen below.

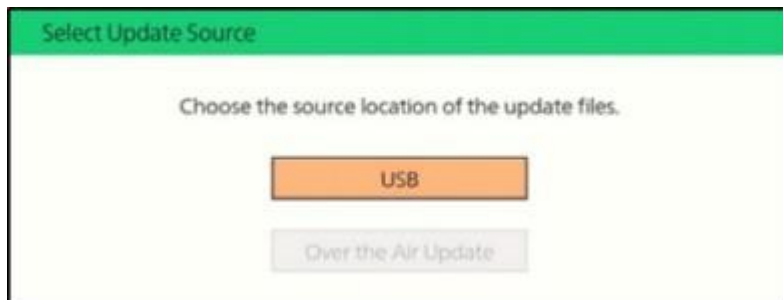
j. Select "USB" on the screen below to start checking for the update file.

**NOTE:** If "Update file(s) not found" message appears, the wrong file may be stored on the USB memory stick or the vehicle has already been updated.

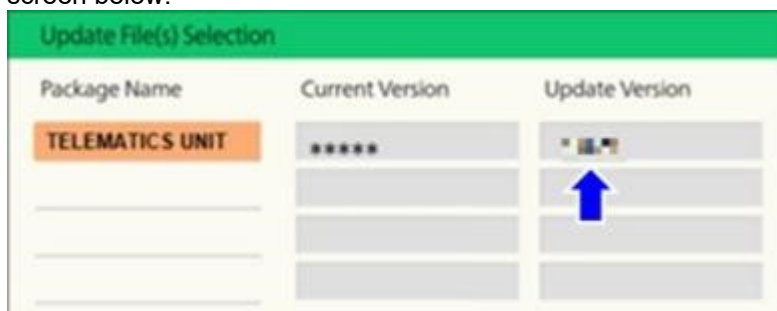
k. Confirm the correct software version is shown under "Update Version" and select "TELEMATICS UNIT" on the screen below.

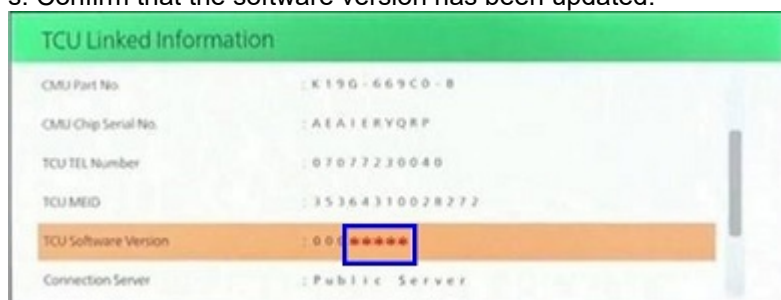
r. Select "TCU Linked Information", then scroll down to TCU Software Version.

s. Confirm that the software version has been updated.
