# Service Bulletin

Bulletin No.: 24-NA-063

Subject: Service Driver's Assist Message Illuminated in DIC with DTC B2BA1 Set

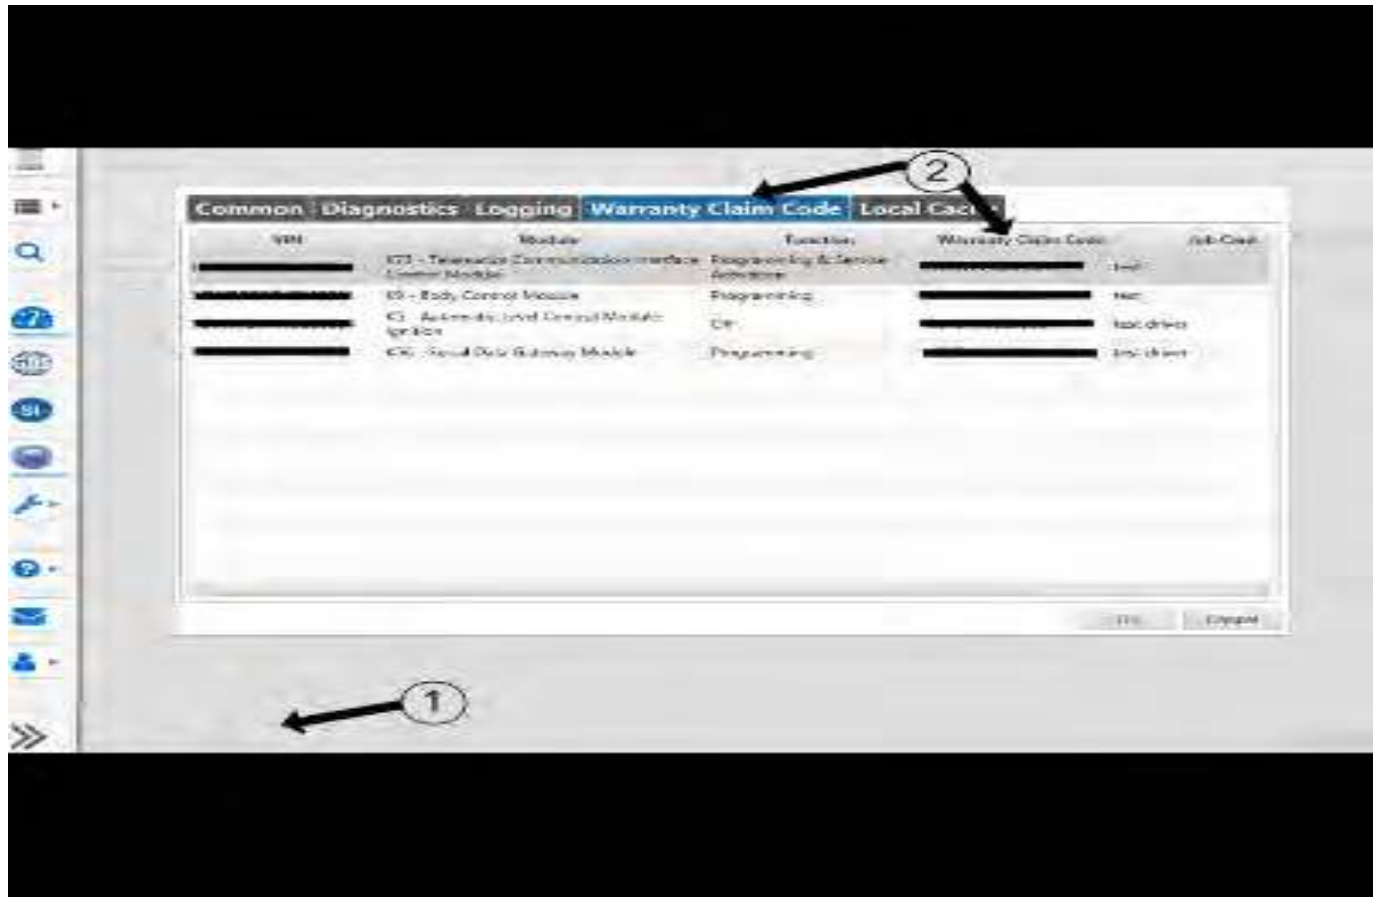
6125774

Warranty Claim Code Information Retrieval

If the Warranty Claim Code was not recorded on the Job Card, the code can be retrieved in the SPS2 system as follows:

The VIN, Warranty Claim Code and Date/Time will be listed on a roster of recent programming events. If the code is retrievable, dealers should resubmit the transaction making sure to include the code in the SPS Warranty Claim Code field.
