# Technical Service Bulletin

## 19 Cabin heating, cooling insufficient, drive system malfunctions, DTCs P2B3000 or P2B3200 stored in 00C5

19 24 57 2073599/1 April 8, 2024.

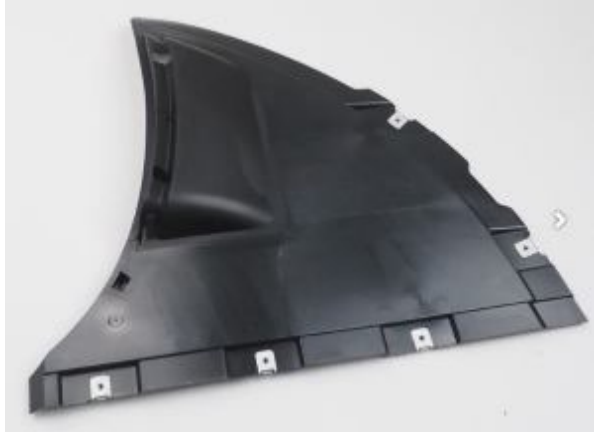
| Part Number | Part Description | Quantity |
|---|---|---|
| 9J1809958D | <br>Lower wheel house protector / spoiler, right side | 1 |

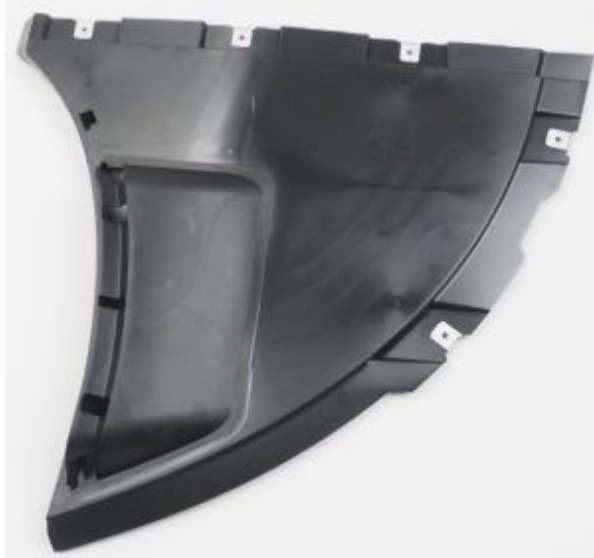
| Part Number | Part Description | Quantity |
|---|---|---|
| 9J1809957D | <br>Lower wheel house protector / spoiler, left side | 1 |

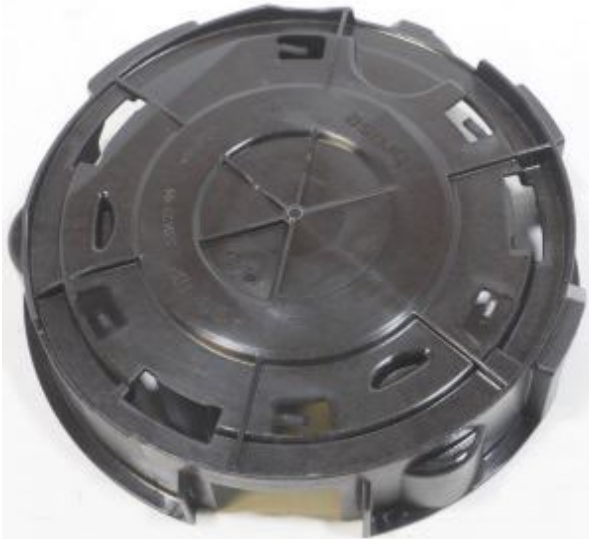
| 9J1959725A | <br>Protective cap, right side | 1 |

Several components have been modified to prevent dirt and stones from entering the fan motor. The new components have additional, larger openings on the underside through which foreign objects can escape and a protective cap on the fan's electric motor to prevent foreign objects/dirt from getting in. If replacement of the cooling fan is necessary in this repair check the version of the wheel spoiler and wheel housing liner and replace all parts on the side being serviced with the new version components.

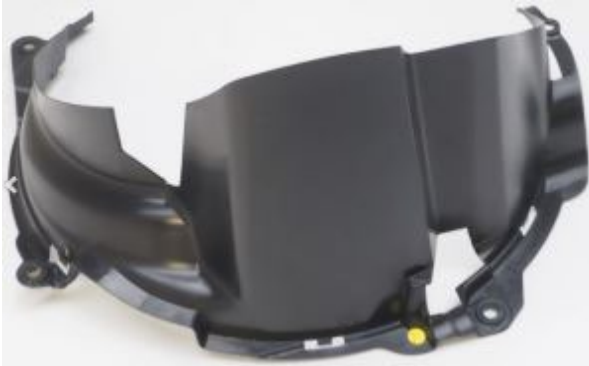
| 9J1121674A | <br>Air duct, right side | 1 |
