## Mil Is On With DTC P0011

### AFFECTED VEHICLES

| Year | Model | Trim Level | VIN Range |
|---|---|---|---|
| 2024 | Integra | Type S | ALL |

MIL comes on and sets DTC P0011 (Variable Valve Timing Control (VTC) A System Malfunction).

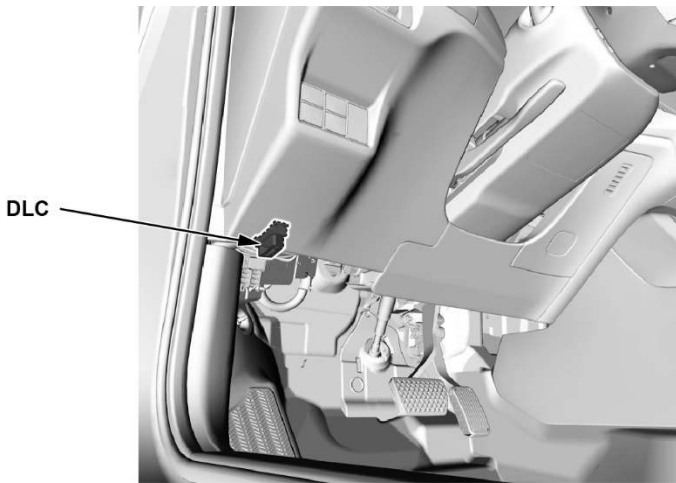
4. Connect the i-HDS to the DLC.
