| <b>Subject:</b><br><br>"TELEMATICS MALFUNCTION" MESSAGE WITH DTC U3000:04-TCU | <b>Bulletin No.:</b> 09-001/24 |

**DESCRIPTION**

## REPAIR PROCEDURE

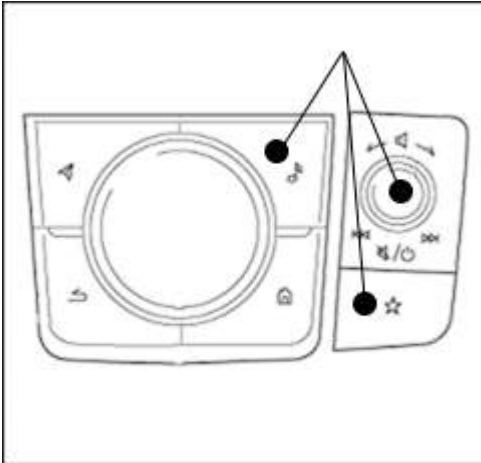
[MAZDA3, MX-30, CX-30, CX-50, CX-90]

g. Press and hold the Volume knob, then press and hold the Entertainment and Favorites buttons at the same time for 3-5 seconds and the Factory/Service Inspection screen will appear.

q. Perform step g to move to the Factory/Service Inspection screen and select "Service Information".

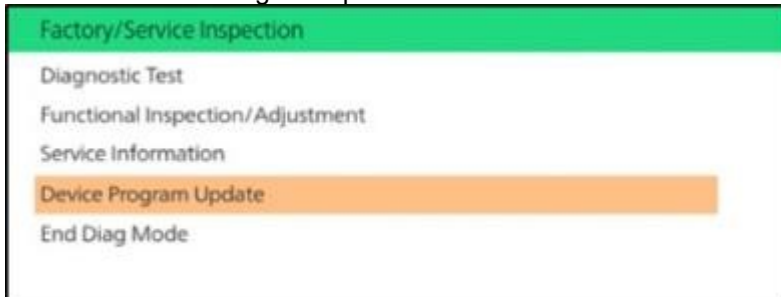
h. Select "Device Program Update" on the screen below.

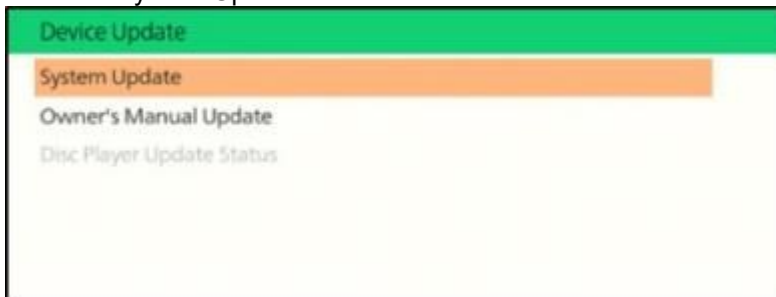
i. Select "System Update" on the screen below

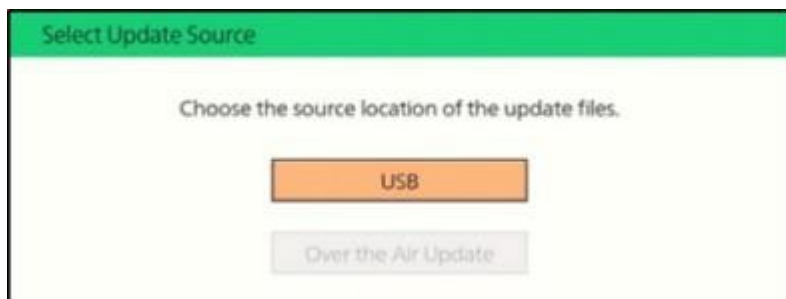
j. Select "USB" on the screen below to start checking for the update file.

**NOTE:** If "Update file(s) not found" message appears, the wrong file may be stored on the USB memory stick or the vehicle has already been updated.

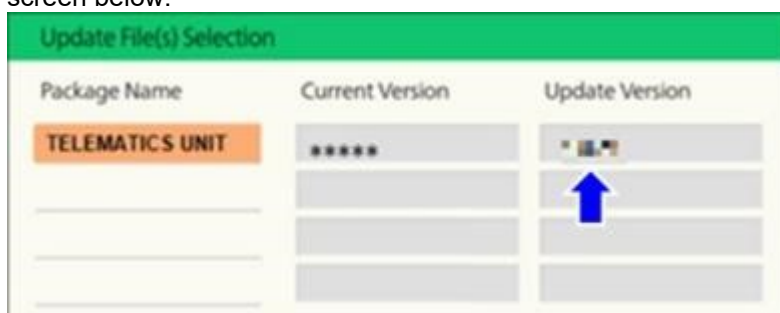
k. Confirm the correct software version is shown under "Update Version" and select "TELEMATICS UNIT" on the screen below.

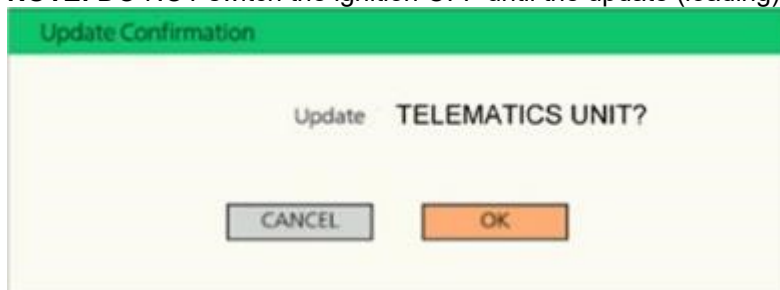
l. Select "OK" on the screen below and wait until the update (loading) is completed.

**NOTE:** DO NOT switch the ignition OFF until the update (loading) is completed.

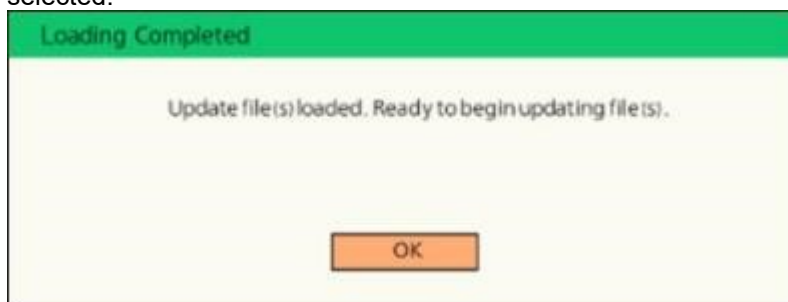
m. Select "OK" on the screen below or the data update will start automatically after 10 seconds if "OK" is not selected.

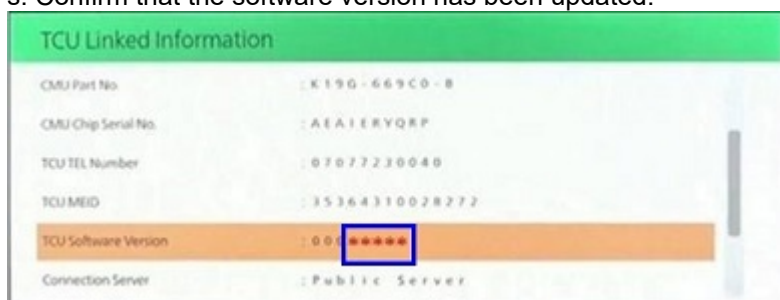
r. Select "TCU Linked Information", then scroll down to TCU Software Version.

s. Confirm that the software version has been updated.
