2024MY  
EV9 (MV)

337 (Rev 1, 7/10/2024)

## TECHNICAL SERVICE BULLETIN

SERVICE ACTION: INTEGRATED CHARGING CONTROL UNIT  
LOGIC IMPROVEMENT (SA568)

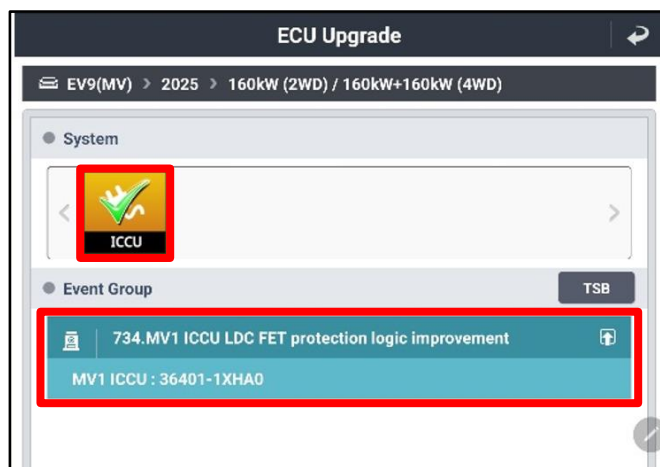
Prior to performing the ECU upgrade, be sure to check that the KDS is fully charged.
