# Service Bulletin

Bulletin No.: 24-NA-010

**Subject:** Service Brake System Message and DTC C2A17 Set or Stored

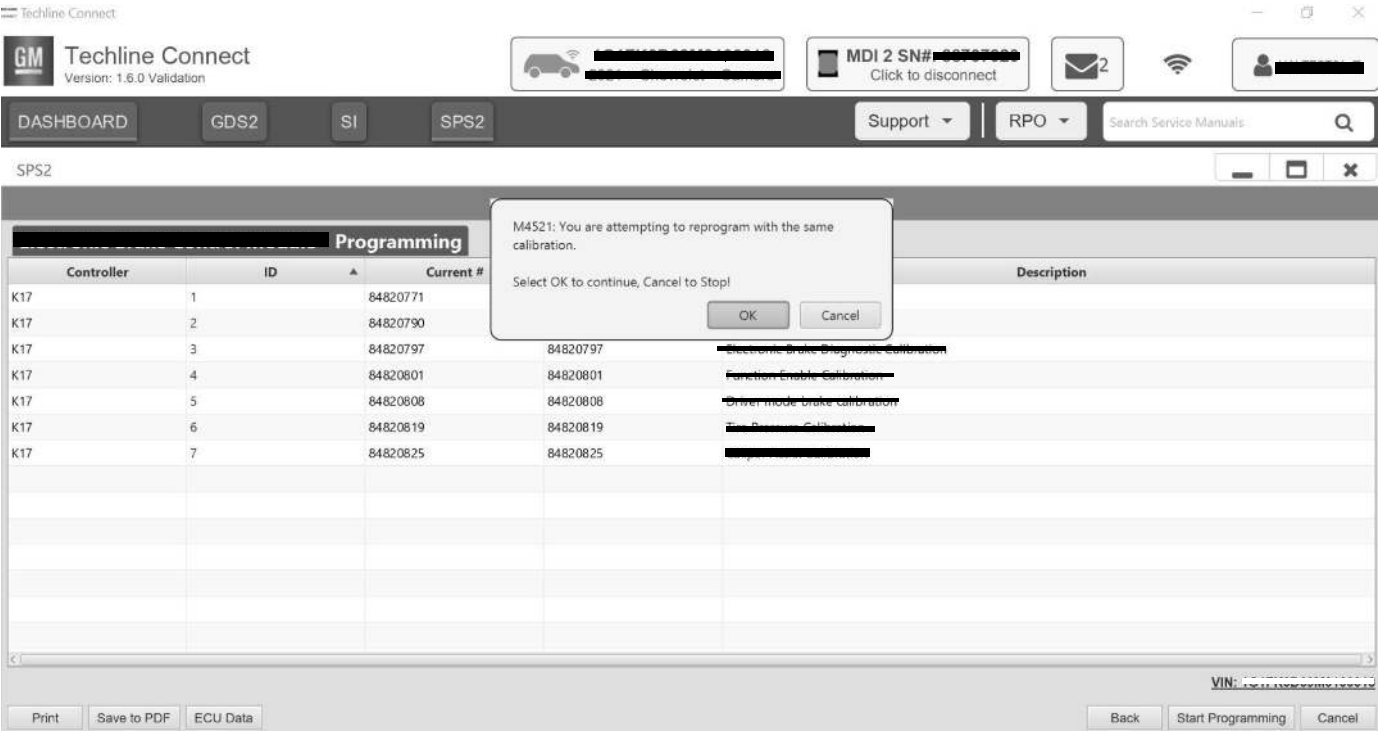
5644477

**Important:** Techline Connect screens shown above.  
**Important:** If the same calibration/software warning is noted on the TLC Summary screen, select OK and follow screen instructions. After a successful programming event, the WCC is located in the Service Programming System dialogue box of the SPS

Summary screen. No further action is required. Refer to the Warranty section of the bulletin.
