Technical product information

| Topic | HVAC intermittently not cooling Diagnostic Trouble Code(s) U1A2900 and / or U1A2A00 evident |

Continental GT / GTC and Flying Spur

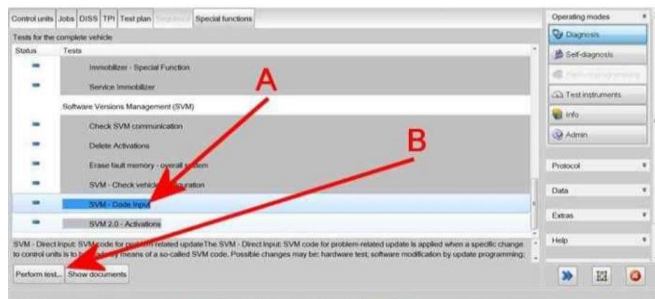
- Referring to Figure 1 - Within the Special functions tab select SVM - Code Input (A) then select Perform test (B)

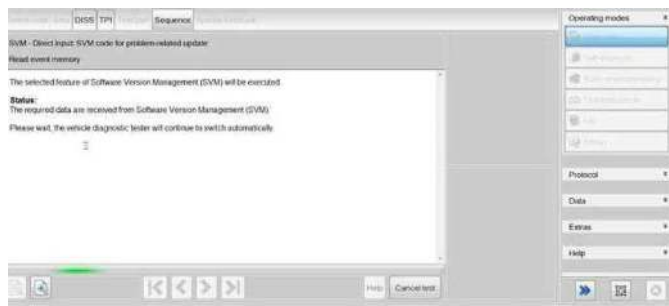
Figure 2

2) On the next screen enter the correct SVM code (Figure 2) depending on model as shown below

New Continental GT and New Continental GTC - 37008SW3075

New Flying Spur - 37108SW3075

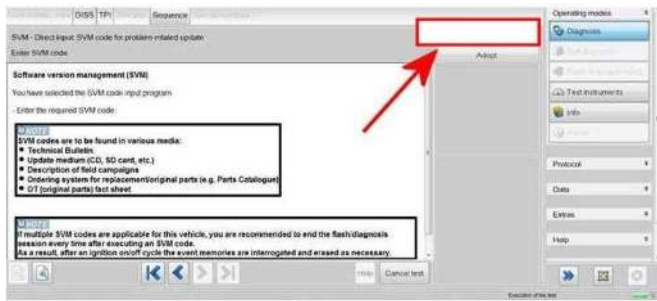
Figure 3

- All control modules will be interrogated
- The SVM action will then take place (Figure 3)
