# Service Bulletin

Bulletin No.: 24-NA-214

**Subject: Medium Duty L5D Trucks Setting DTC P2959**

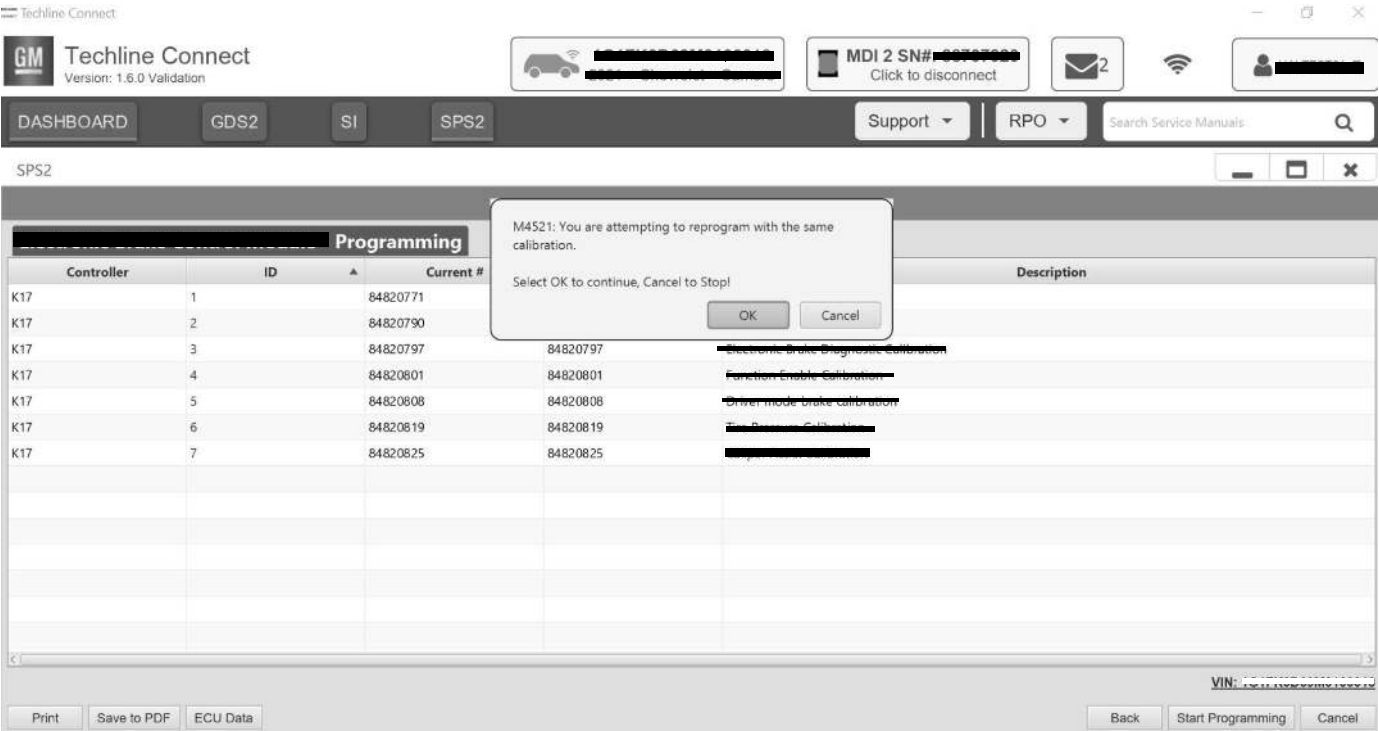
5644477

**Important:** Techline Connect screens shown above.

**Important:** If the same calibration/software warning is noted on the TLC Summary screen, select OK and follow screen instructions. After a successful programming event, the WCC is located in the Service Programming System dialogue box of the SPS Summary screen. No further action is required. Refer to the Warranty section of the bulletin.

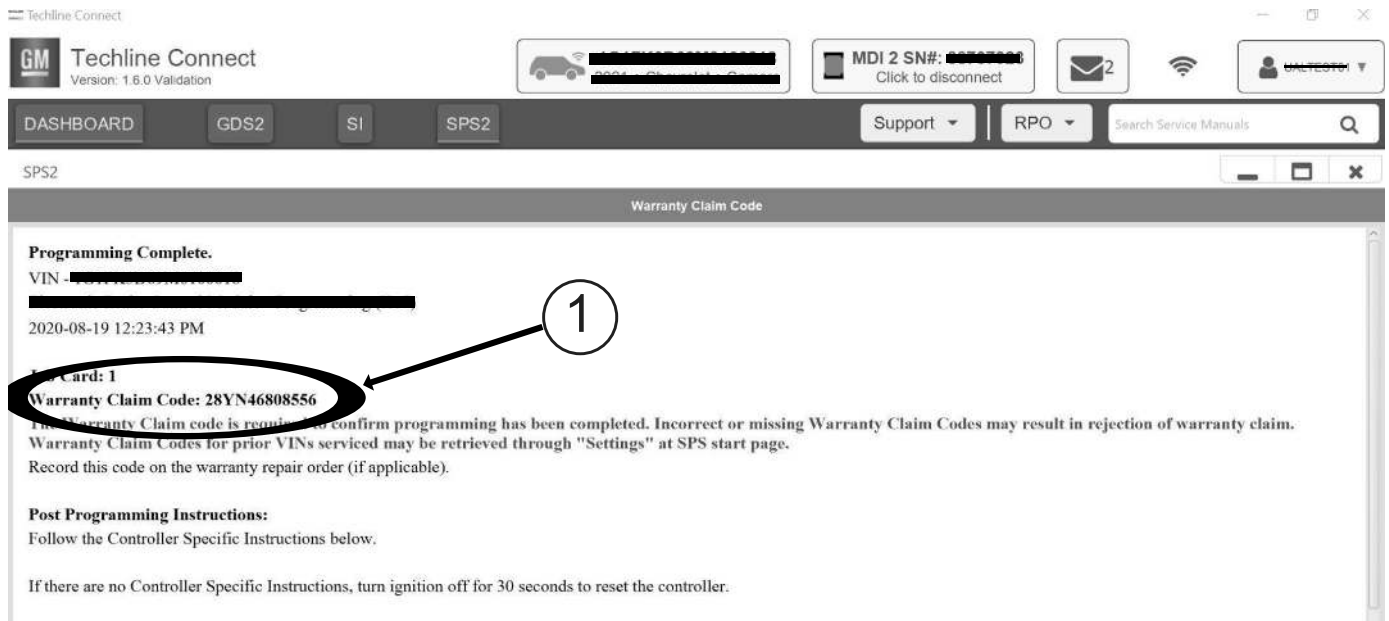
5644478

**Note:** The screenshot above is an example of module programming and may not be indicative of the specific module that is being programmed. Module selection and VIN information have been blacked out.
