2010-2011MY  
Forte & Forte Koup (TD)  
w/2.4L MPI

PI2102Y/Z (Rev 2, 11/07/2024)

ENGINE REPLACEMENT INSTRUCTIONS  
FOR DTC P1326 (PI2102Y/Z)

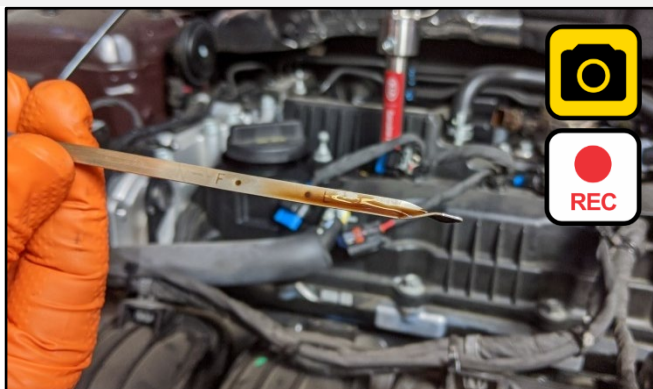
1. Start video showing vehicle and move in towards the dash VIN tag.
2. Measure and record oil dip stick level.
3. Note oil dip stick reading on the RO.
4. Take a picture of the oil reading on dipstick.

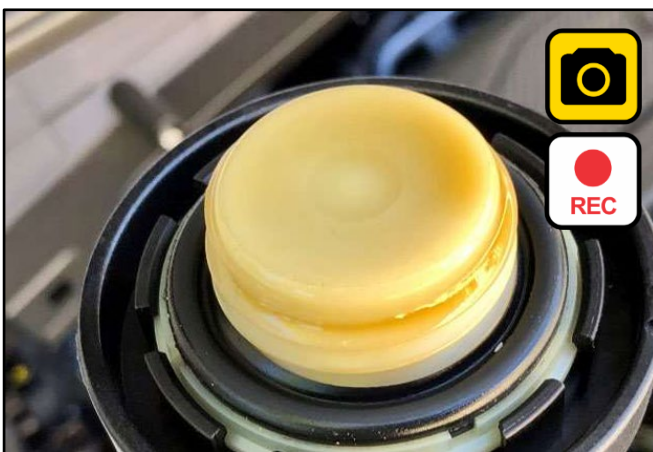
5. Inspect the inner/bottom of the oil cap and inside oil filler opening.

6. Take a picture of both, the bottom of the oil cap and oil filler opening.

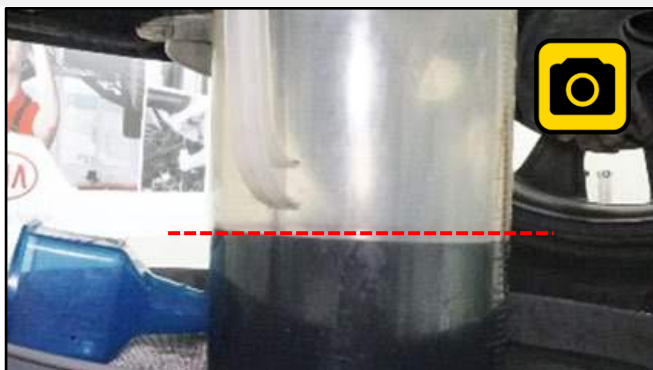
**Oil Level Measurement: (Main Flowchart → PWA Request) NO OIL READING ON DIPSTICK**

1. Remove oil filler cap, remove oil drain plug and drain oil into the measuring container SST067BUCK and check oil level.
2. Record oil level reading on the RO.
3. Take photo of the drained oil container using KDS and attach to warranty claim PWA request.

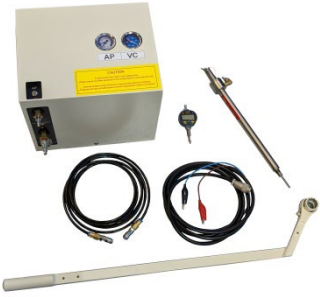
| Tool Name | Tool Part No. | Figure | Comments |
|---|---|---|---|
| Bearing Clearance Tester Kit | KQ231 2T110QQK | | Auto-shipped to Dealers<br>For troubleshooting assistance contact the GITA Support Line at: (888) 542-4371.<br><br>For replacement parts, contact Snap-On Tools at: (888) 542-1011. |

If DTC P1326 is present, first perform the bearing clearance inspection with the Engine Bearing Clearance Tester device (SST KQ231-2T110QQK). This device checks the rod bearing clearance by placing air and vacuum into the cylinder block. Measure the bearing clearance and follow the instructions in this bulletin. Refer to the flow chart found on pages 2-4, then follow the appropriate procedure as outlined in this bulletin. Before conducting the procedure, verify the vehicle is included in the list of affected VINs.

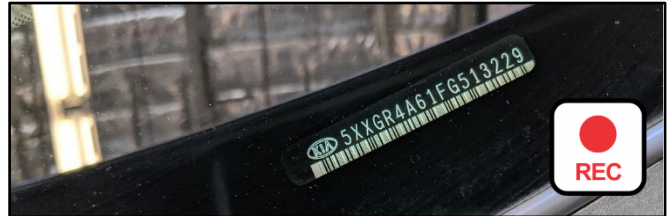
**Prepare the vehicle prior to the video by removing the spark plugs and drive belt as well as setting the torque wrench to 94 lb.ft.**

1. Start video showing the vehicle being worked on and move the camera in towards the dash VIN tag.

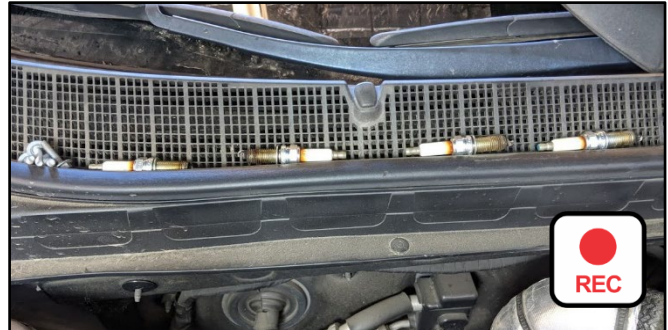
2. Show the removed spark plugs.

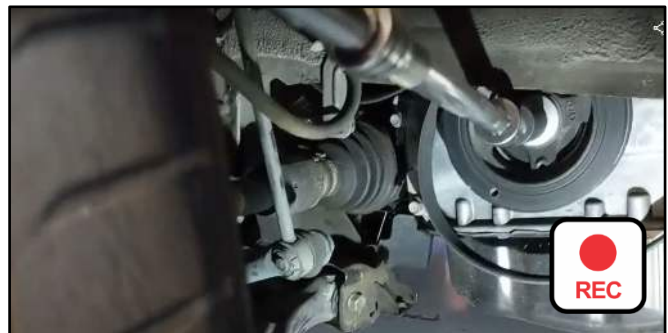
5. Show the removed drive belt and attached torque wrench to crank bolt.
