| | Subsequent Repair Action | 2019-2020MY<br>Optima P/HEV (JF P/HEV)<br>w/Nu 2.0L GDI |
| SUBJECT: ENGINE REPLACEMENT INSTRUCTIONS<br>FOR DTC P1326 (PI2108Y/Z) | | |

This bulletin provides information related to the Technical Service Bulletin previously published in (PI2108) titled "Knock Sensor Detection System - ECU Logic Improvement" for certain 2019-2020MY Optima P/HEV (JF P/HEV) vehicles equipped with Nu 2.0L GDI engine, produced from July 6, 2018 through October 28, 2019. Specifically, this bulletin provides instructions on which procedures to follow if, after installation of the KSDS, any one of the subject vehicles below return to the dealer with Diagnostic Trouble Code (DTC) P1326 (Knock Signal Range/Performance).

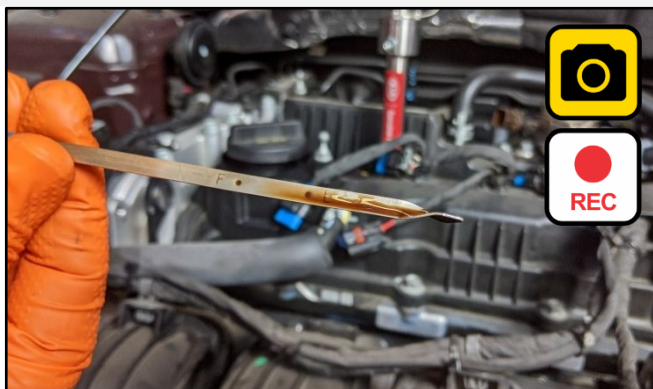
1. Start video showing vehicle and move in towards the dash VIN tag.
2. Measure and record oil dip stick level.
3. Note oil dip stick reading on the RO.
4. Take a picture of the oil reading on dipstick.

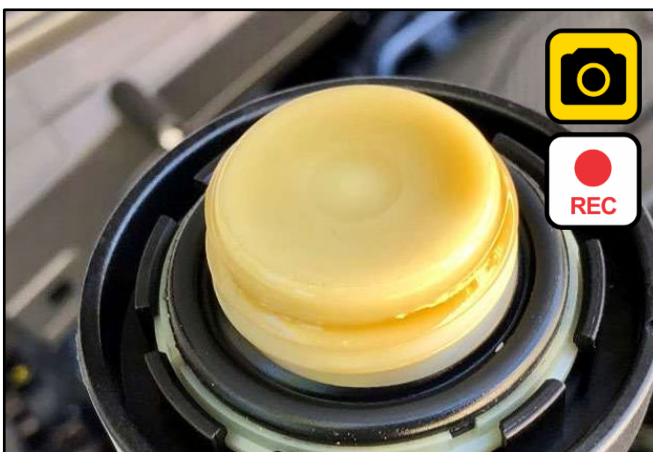
5. Inspect the inner/bottom of the oil cap and inside oil filler opening.

6. Take a picture of both, the bottom of the oil cap and oil filler opening.

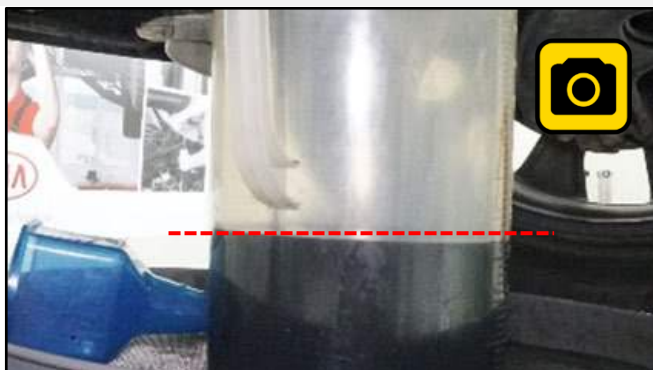
**Oil Level Measurement: (Main Flowchart → PWA Request) NO OIL READING ON DIPSTICK**

1. Remove oil filler cap, remove oil drain plug and drain oil into the measuring container SST067BUCK and check oil level.
2. Record oil level reading on the RO.
3. Take photo of the drained oil container using KDS and attach to warranty claim PWA request.

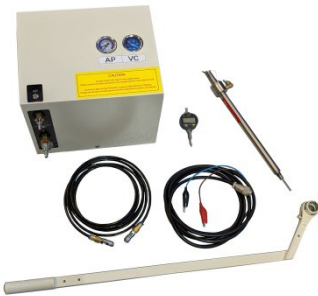
| Tool Name | Tool Part No. | Figure | Comments |
|---|---|---|---|
| Bearing Clearance<br>Tester Kit | KQ231 2T110QQK | | <p>Auto-shipped to Dealers</p> <p>For troubleshooting assistance contact the GITA Support Line at: (888) 542-4371.</p> <p>For replacement parts, contact Snap-On Tools at: (888) 542-1011.</p> |

If DTC P1326 is present, first perform the bearing clearance inspection with the Engine Bearing Clearance Tester device (SST KQ231-2T110QQK). This device checks the rod bearing clearance by placing air and vacuum into the cylinder block. Measure the bearing clearance and follow the instructions in this bulletin. Before conducting the procedure, verify the vehicle is included in the list of affected VINs.

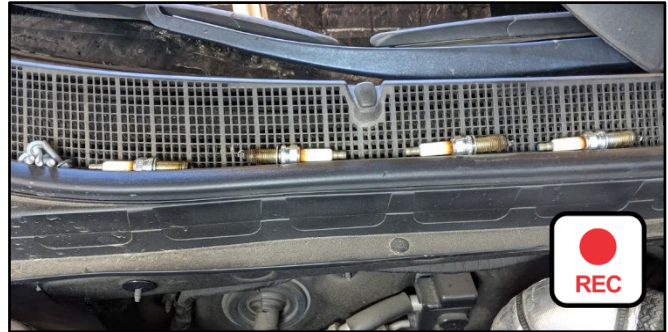
2. Show the removed spark plugs.

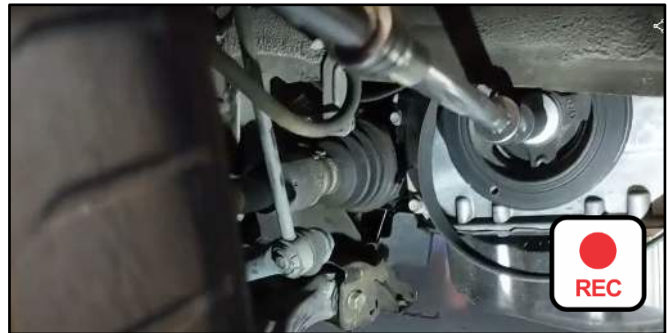
5. Show the removed drive belt and attached torque wrench to crank bolt.

**Prepare the vehicle prior to the video by removing the spark plugs and drive belt as well as setting the torque wrench to 94 lb.ft.**

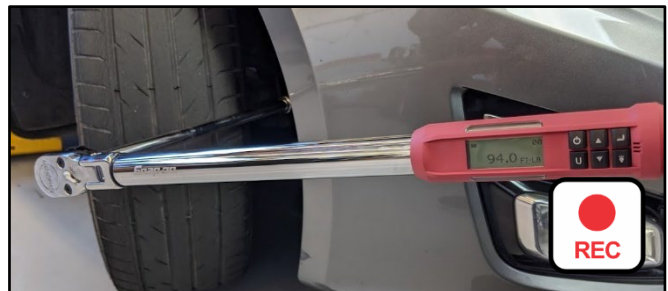
6. Show the engine being cranked and torque specification exceeding 94 lb.ft. torque.
