# Service Bulletin

Bulletin No.: 24-NA-215

**Subject: Calibration Update for DTCs P2463 and P04DB**

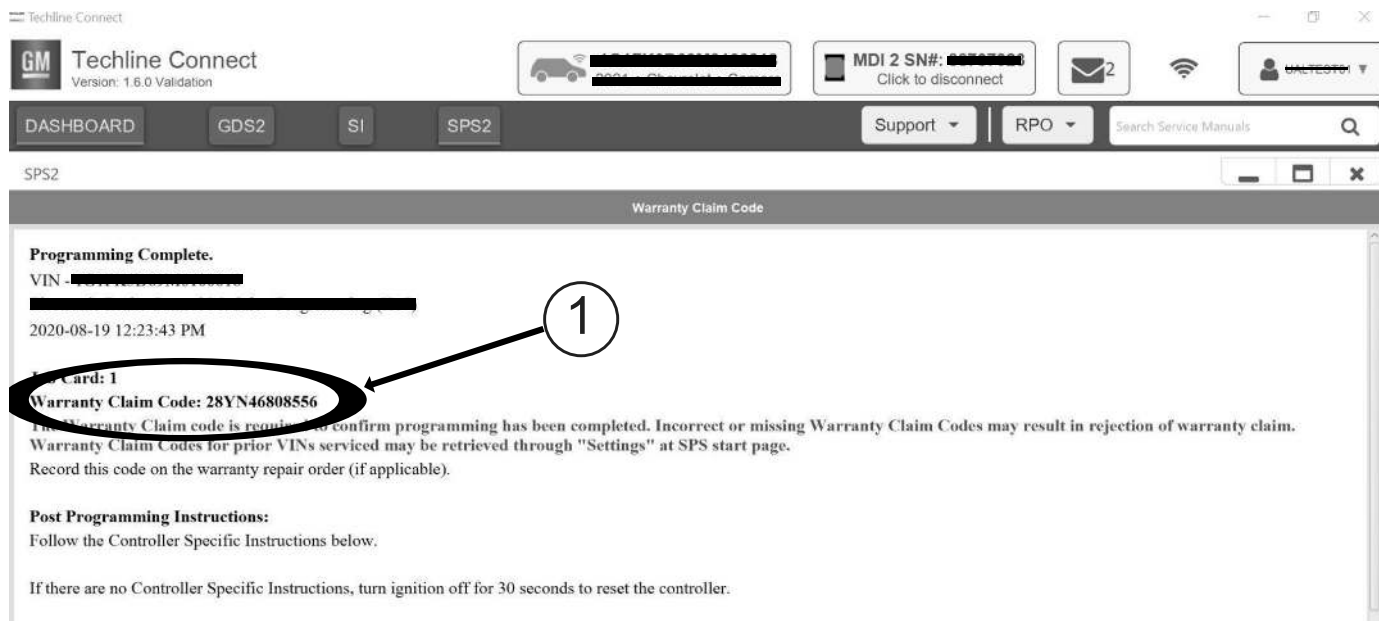
5644478

**Note:** The screenshot above is an example of module programming and may not be indicative of the specific module that is being programmed. Module selection and VIN information have been blacked out.
