# Service Bulletin

Bulletin No.: 24-NA-271  
Date: December, 2024

**Subject: C103D.28 Set Current, Update Software K19 - Suspension Control Module**

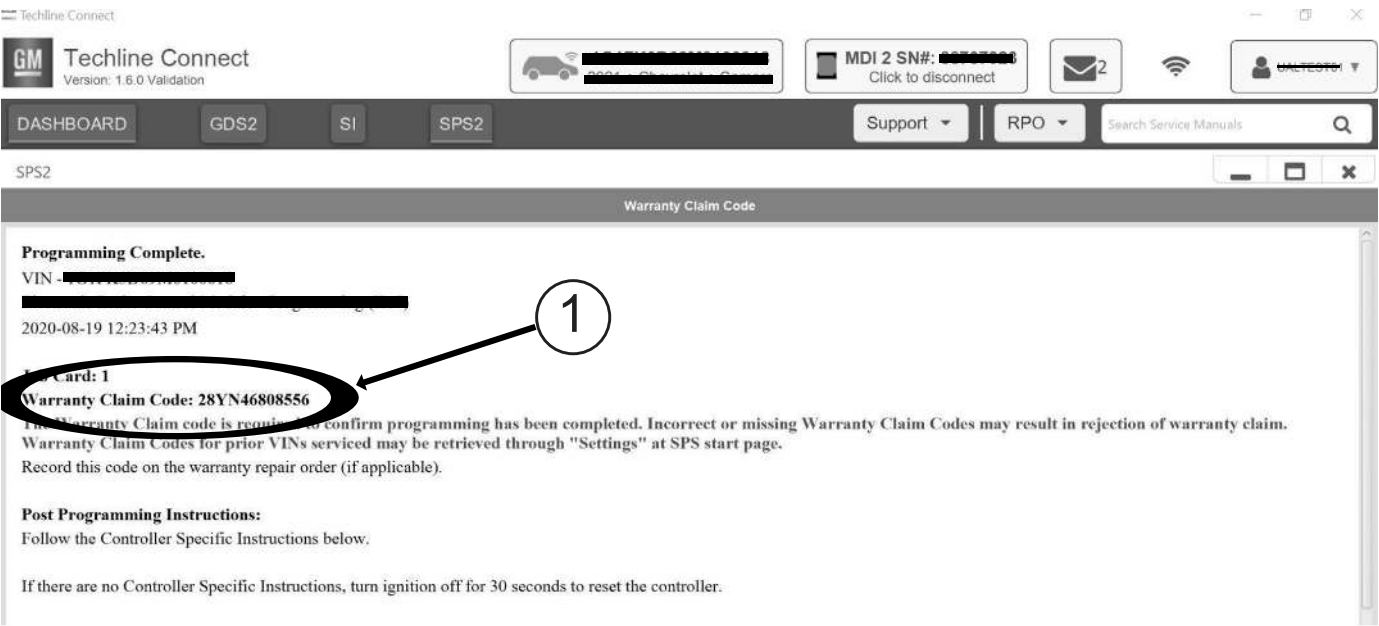
5644478

1. Reprogram the Suspension Control Module. Refer to *K19 Suspension Control Module: Programming and Setup*.

**Note:** The screenshot above is an example of module programming and may not be indicative of the specific module that is being programmed. Module selection and VIN information have been blacked out.
