# Technical Service Bulletin

**SEAT WARMER DOES NOT OPERATE WHEN TURNING IGNITION ON WHILE CABIN TEMPERATURE AND/OR SEAT IS WARM**

**Bulletin No.: 09-005/25**

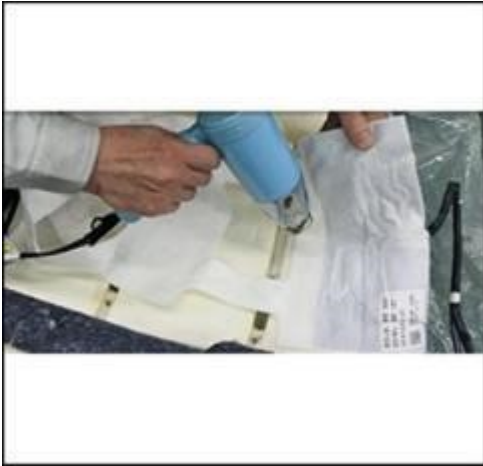
- a. Remove the heater mat gently while using a hair dryer or an iron to warm up the adhesive parts (1).

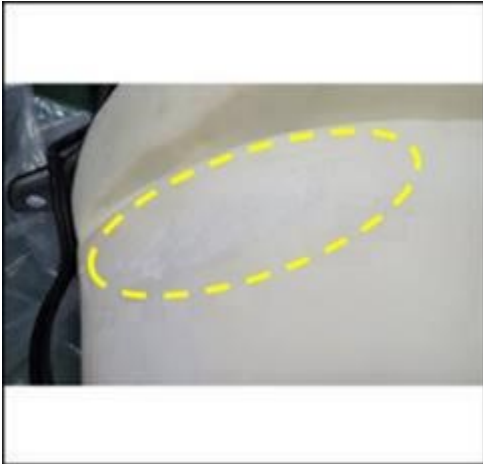
**NOTE:** If the adhesive surface is not warmed up sufficiently, the urethane pad may be damaged (example image below).

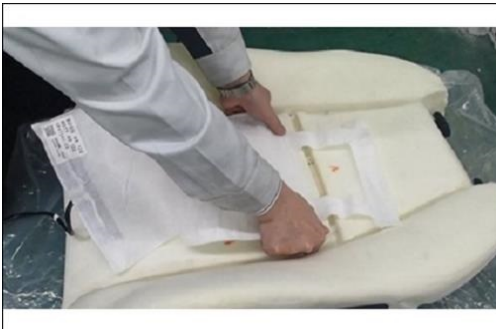
**NOTE:** Location of the markings of the urethane pad

c. Remove the three release papers on the seat warmer unit, and then apply it to the the urethane pad according to the markings on the pad (Refer to the procedure below).

**NOTE:** Align with the seat warmer and the markings on the urethane pad.
