# Service Bulletin

Bulletin No.: 24-NA-148  
Date: January, 2025

**Subject:** Transmission Slip, Harsh 3-4 Shift or Harsh 5-6 Shift, Delayed Shifts, Delayed Shift into Reverse, Harsh Shift into Reverse, Slips in Reverse or No Reverse, Malfunction Indicator Lamp (MIL) Illuminated - DTC P2714 and/or P2732 Set

**Attention:** This TSB only applies to the 10L1000 RPO (MKM) with the 6.6 (L8T) gas engine. This does not apply to 10L1000 (MGM) (MGU) with 6.6 (L5P) diesel engine.

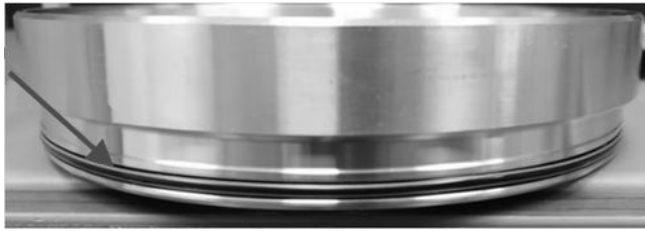
6712757

| Cause | <p>This condition may be caused by the 1-2-3-4-6-7-8-10-Reverse Clutch (C4) may have experienced premature degradation of the C4 Apply Piston Outer Seal (525) due to the seal contact area machine finish of the Triple Clutch Housing (518):</p> |

- A good seal will have an orange stripe.

**Note:** Inspection of the transmission oil pan in many cases, will show no or minimal clutch sediment present. Replacement of the valve body does not resolve the condition. Replace the Triple Clutch Housing (518), 1-2-3-4-6-7-8-10-Reverse Clutch (C4) Apply Piston (523), C4 Apply Piston Outer Seal (525) and the 4-5-6-7-8-9-10-Reverse Clutch (C6) Apply Piston (534).

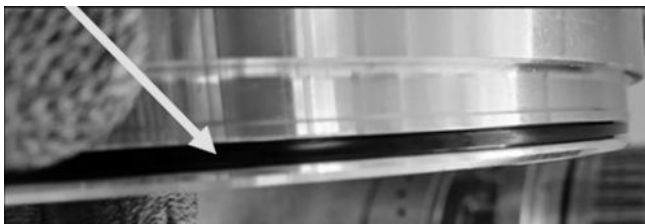
6712755

- A degraded seal will be all black.

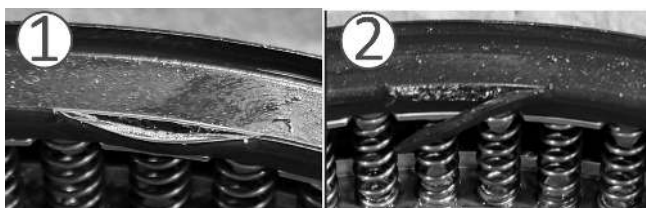
6712761

- The 4-5-6-7-8-9-10-Reverse Clutch (C6) may have experienced a de-bond (1) or tear (2) condition of the C6 Apply Piston (534).
