2011MY  
Sorento (XMa)  
w/Theta 2.4L MPI

SC291YZ (Rev. 1, 03/03/2025)

ENGINE REPLACEMENT INSTRUCTIONS  
FOR DTC P1326 (SC291YZ)

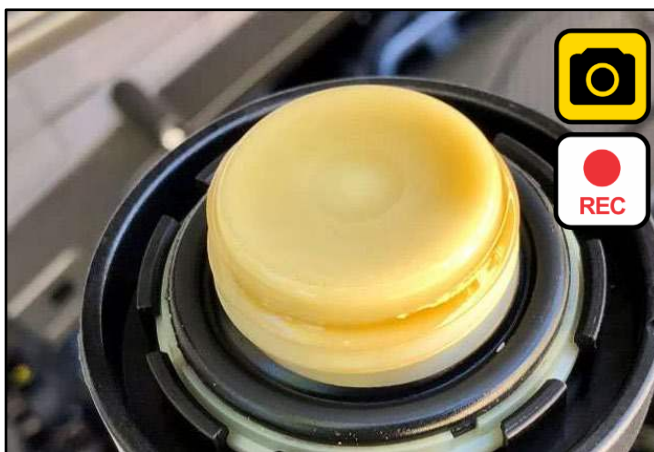
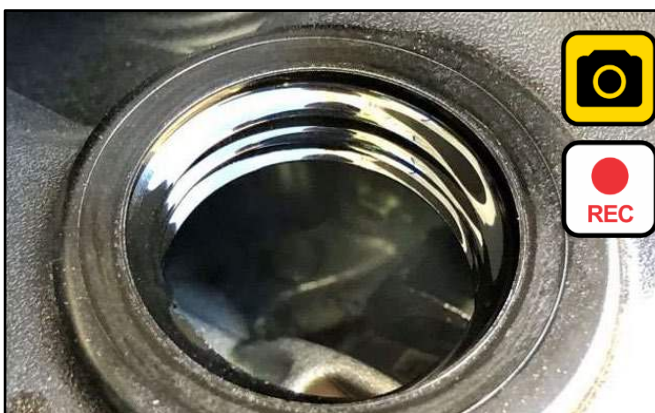
1. Start video showing vehicle and move in towards the dash VIN tag.
  2. Measure and record oil dip stick level.
  3. Note oil dip stick reading on the RO.
  4. Take a picture of the oil reading on dipstick.
- Inspect the inner/bottom of the oil cap and inside oil filler opening.
- 5.
  6. Take a picture of both, the bottom of the oil cap and oil filler opening.

**Record/Note findings:** No oil, oil sludge, varnish, burnt oil smell condition(s) found.

If NO oil is registered on the dipstick, or oil lacquering, oil sludge and/or oil varnish is present (NG), then the engine is therefore suspect to maintenance neglect. Review of the vehicle's maintenance history is required.

If suspect, proceed to the 'Oil Level Measurement' instructions below and submit with the Techline case.

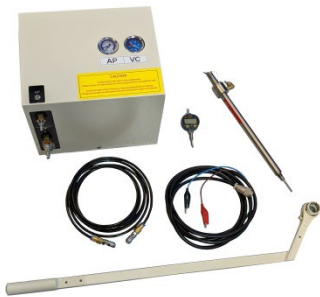
| Tool Name | Part Number | Figure | Comments |
|---|---|---|---|
| Bearing Clearance Tester Kit | KQ231 2T110QQK | | Auto-shipped to Dealers<br><b>For troubleshooting assistance contact the GITA Support Line at: (888) 542-4371.</b><br><br><b>For replacement parts, contact Snap-On Tools at: (888) 542-1011.</b> |

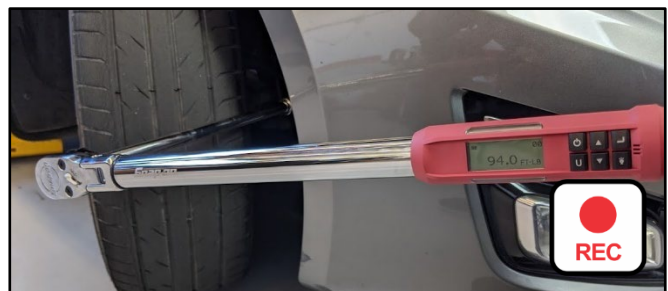
6. Show the engine being cranked and torque specification exceeding 94 lb.ft. torque.
