| <b>Topic</b> | 91 PSS Reversing camera - rear corner view cannot be activated via the MMI |
| <b>Brand</b> | Audi |
| <b>Transaction No.</b> | 2076961/1 |

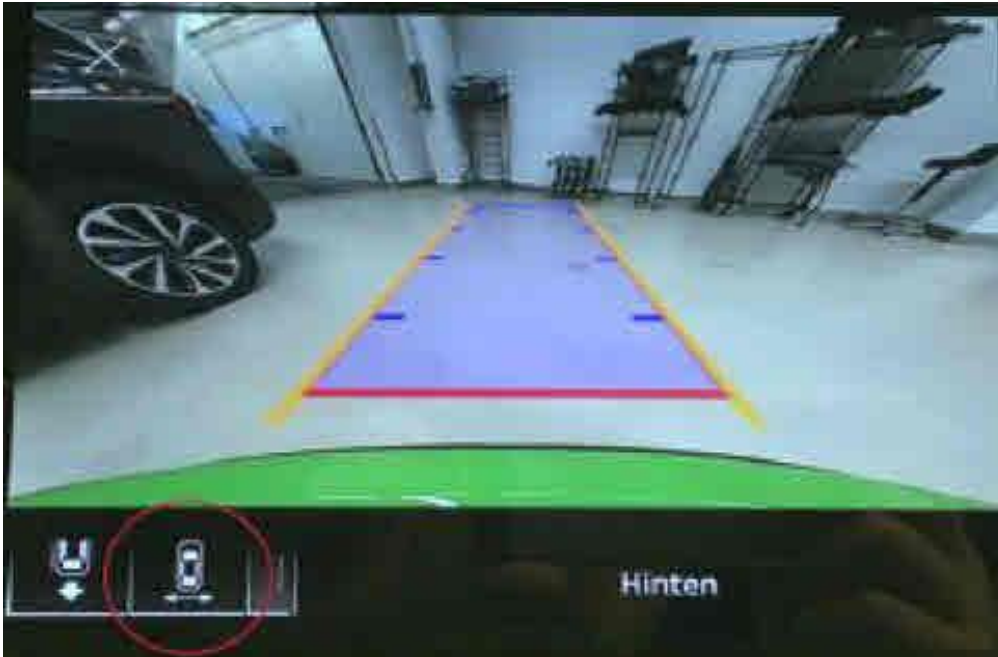
The reversing camera view cannot be changed via the MMI. The rear corner view cannot be activated. Please compare the complaint with the attached image.

**Figure 1.** Reversing Camera View Change Button

Software issue. The soft keys shown have no function and should not appear in the reversing camera view.

With software version 2091 in Data Bus On Board Diagnostic Interface, J533 (address word 0019) in week 48/2024.

1. Explain to the customer that a solution is expected to be available by the end of the 2<sup>nd</sup> quarter of 2025 (subject to change) and that no repairs are necessary at this point.
2. Do not replace any components for this condition since this will not resolve the customer's concern.
