# Technical Service Bulletin

| Topic | Engine overheating - Warning in the DIP (V8 Kovomo) |
| Brand | Bentley |
| Transaction No. | 2061369/9 |

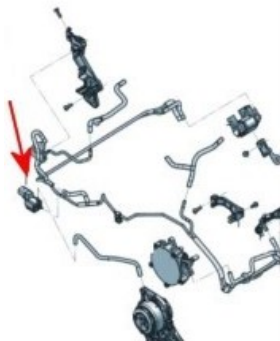
To allow the engine coolant to heat as quickly as possible (from cold start) coolant delivery from the mechanical coolant pump is interrupted by switch valve N649

Figure 2 - New Continental GT/ GTC and Flying Spur
