# Technical Service Bulletin

CHECK ENGINE LIGHT ON WITH DTC P0126:00

Bulletin No.: 01-003/25

Last Issued : 03/13/2025

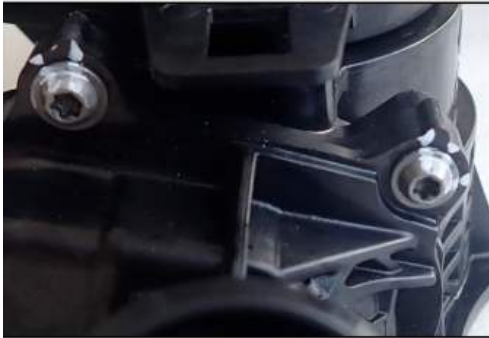
**Marking Example 1:** Draw lines over the screws and the thermostat cover as shown above.

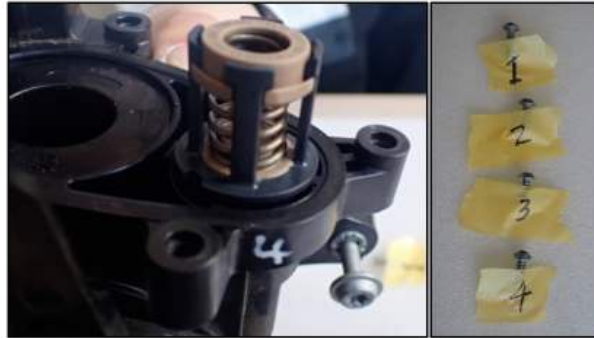
**Marking Example 2:** Number each screw and their respective hole as shown above.
