## STAR ONLINE PUBLICATION

**Case Number:** S2503000003

**Symptom/Vehicle Issue:** Rear Axle Locker Inoperative, Service Axle Locker Message Displayed.

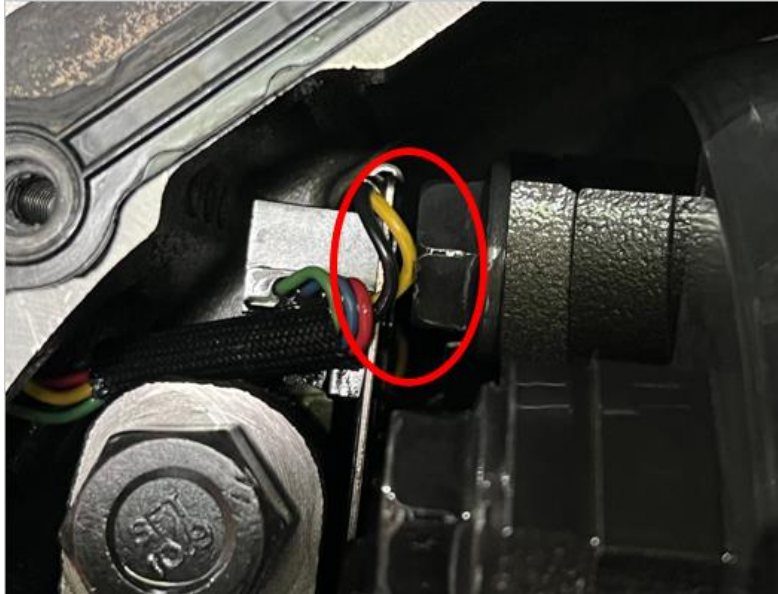
**Figure 1**

1. Remove the rear differential cover.
2. Inspect the e-locker actuator wiring harness for damage due to contact with the differential. Please see (**Figures 1 & 2**).

3. If the wiring insulation was found rubbed through, but the wiring is still intact, please repair the wiring per normally wiring repair guidelines. Be sure to secure the wiring so that it no longer contacts the differential.
4. If the wires were found cut, please replace the e-locker actuator.

**NOTE: The e-Lock differential lock actuator is available as a separate service part from the differential and axle assembly. DO NOT replace the differential assembly or complete axle if the actuator requires replacement.**
