## Technical Service Bulletin

| <b>Topic</b> | 57 Various complaints regarding the front or rear door lock, DTC(s) B122D29, B14FF29 or B122B13 |
| <b>Brand</b> | Audi |
| <b>Transaction No.</b> | 2063236/10 |

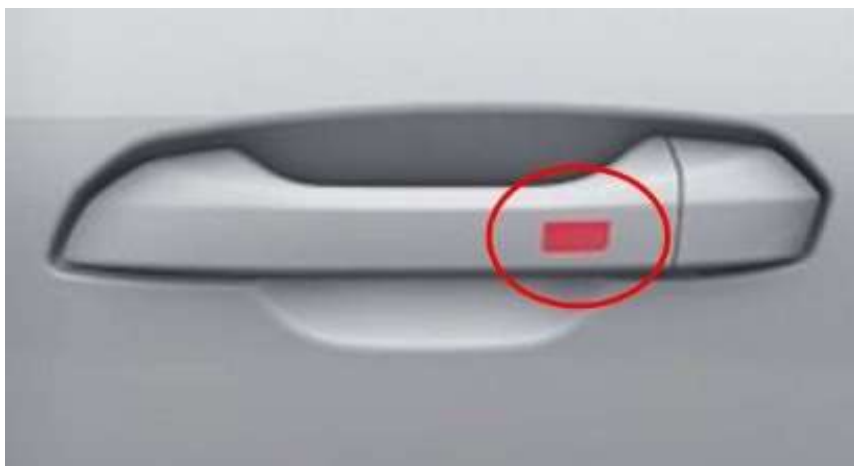
**Figure 1.** Convenience key sensor on door handle.

For vehicles with a mechanical exterior door handle and convenience key (Figure 1; sensor on the door handle), be aware of the possibility of incorrect operation by the customer:

To lock the vehicle, close the door and touch the sensor on the door handle once. Do not take hold of the door handle when doing so, otherwise the vehicle will not be locked. Once the doors have been locked, they cannot be opened again immediately. This will enable you to check that the doors are properly closed.

When opening the doors, care must be taken not to touch the sensor on the exterior door handle at the same time (e.g. with the thumb), as otherwise the vehicle will be locked again → incorrect operation by the user.

If the complaint persists / the event memory entry is still logged after the checks have been performed, proceed according to Guided Fault Finding and work through the steps described.
