HV DC/DC converter N83/1 BUCK mode fluctuations result in ESP warning message

| Topic number | LI42.45-P-079407 |
| Function group | 42.45 - Electronic stability program (ESP) |

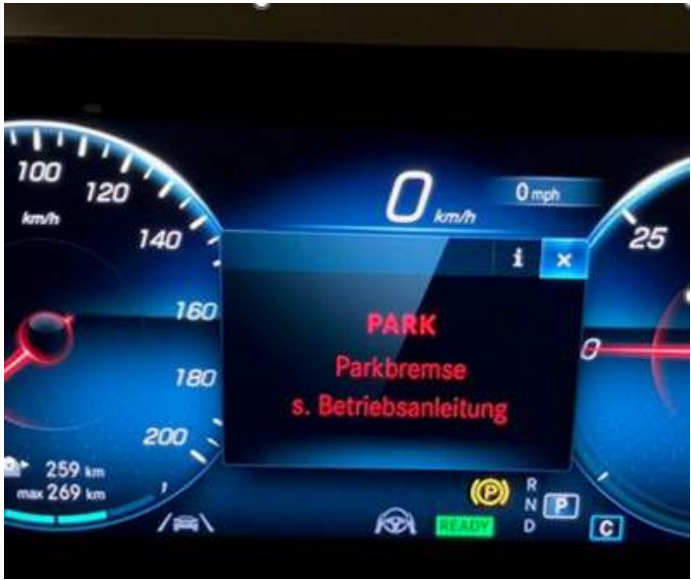
| Attachments | |
|---|---|
| DCDC KAMAYA Parkbremse Meldung KI DE.jpg | Warning message EPB, German |

Instrument cluster warning lamp and/or warning message for brake system, EPB, ESP (yellow or red) and possibly 12 V battery (red)

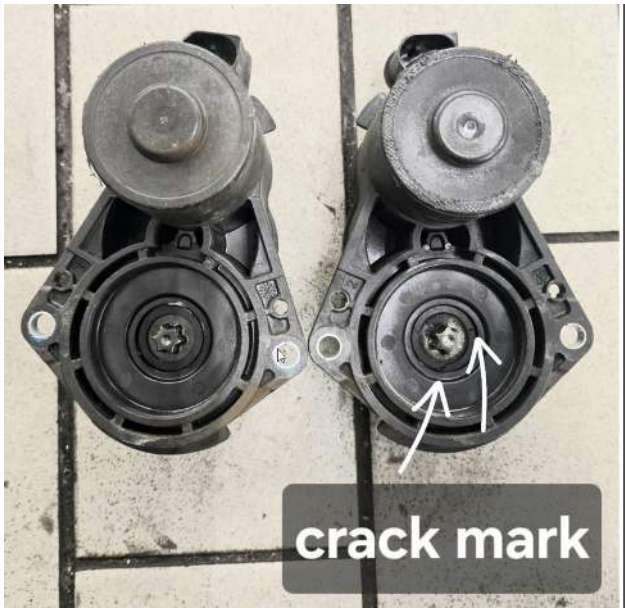
EPB Aktuator Sicherungsring gebrochen.jpg

Actuator, retaining ring (possible defect)

- Check of the actuators and brake caliper piston
- Manually extend and retract the piston on the brake caliper completely using the suitable socket
- If the piston sticks at a certain point, the rotation force increases significantly
- If the brake caliper piston sticks, the brake caliper has to be replaced
- If the retaining ring of the actuator is broken, the actuator has to be replaced
- In XENTRY, edit the stored test instructions of the remaining DTCs
