## Technical Service Bulletin

| <b>Topic</b> | 87 Air conditioner does not work, no cooling output - P053000, P251500 stored in C5 |
| <b>Brand</b> | Audi |
| <b>Transaction No.</b> | 2068460/7 |

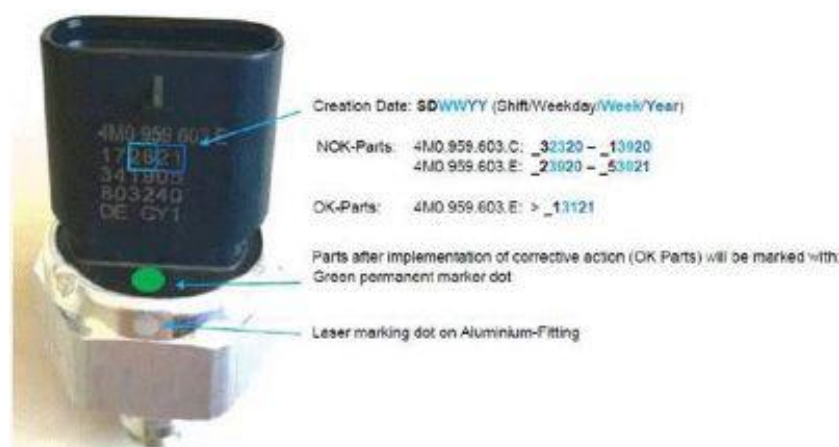
When performing the work, please make sure that a pressure sensor was not previously replaced. This can be seen by the following markings on the sensor:

**Figure 1.** Manufacture dates and serial numbers on sensor.

- Sensors which have previously been replaced can be recognized by the following criteria:
- Green dot on the plastic part (not always present, depending on the production date of the sensor)
- Laser marking on the aluminum part
- Production date of sensor >3121 (31 = week / 21 = year of manufacture)
- Component already has index E and the markings described

Please replace all pressure sensors in the air conditioning circuit.

If index E can no longer be ordered from the replacement parts warehouse, sensors with index J are available. In this case, please note that the two sensors are not compatible. If a sensor is replaced with an index J version, all other sensors in the affected vehicle must also be replaced with an index J sensor. Sensor E must be ordered if it is in the replacement parts warehouse.
