## Technical Service Bulletin (TSB)

### Aisin K1 Clutch/Input Shaft Assembly Replacement XW1 Warranty Extension

| REFERENCE: | TSB: 21-041-25<br>GROUP: 21 - Transmission and Transfer Case | Date: | October 4, 2025 | REVISION: | - |

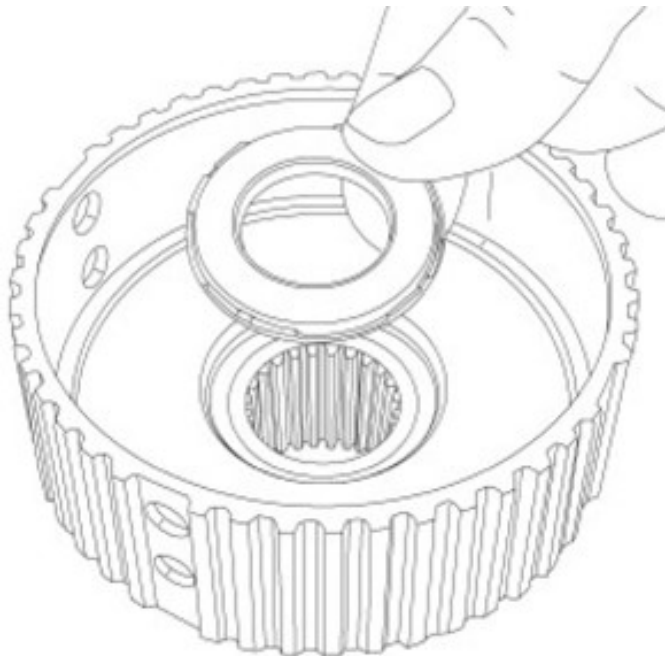
**Fig. 9**

12. Remove and inspect the K1 thrust bearing number two [Fig. 9](#). **Replace only if needed.**

K1 Thrust Bearing Number Two

16. Install the K2 clutch hub into the transmission case [Fig. 11](#).  
17. Lubricate with trans jel or petroleum jelly and install K1 thrust bearing number two into K1 Clutch Hub [Fig. 9](#).

18. Install the K1 clutch hub and thrust bearing into the transmission case [Fig. 9](#).  
19. Apply trans jel or petroleum jelly onto the new input shaft seal rings and install the K2 clutch assembly onto the new K1 clutch/input shaft assembly with the original selectable input shaft end-play thrust bearing number one and thrust washer in place [Fig. 9](#).

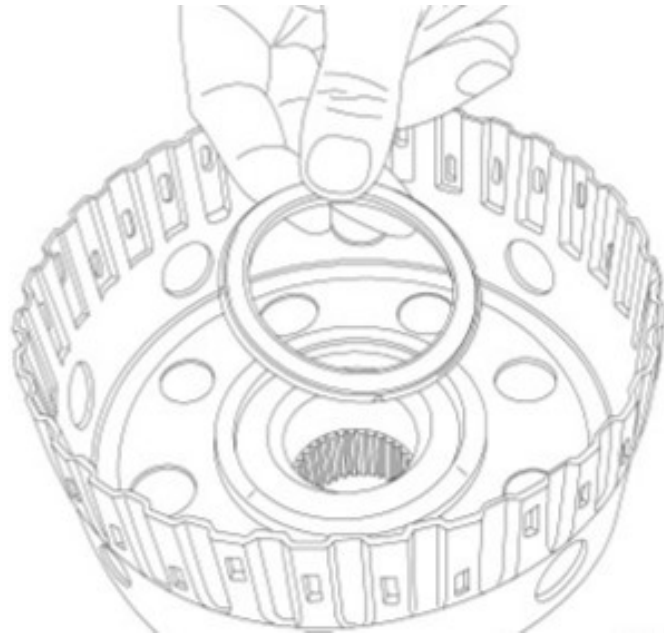
**Fig. 11**

15. Lubricate with trans jel or petroleum jelly and install K2 thrust bearing number three [Fig. 11](#).

K2 Hub Thrust Bearing Number Three
