## Technical Service Bulletin (TSB)

### Brake Warning Lamp On

| REFERENCE: | TSB: 08-275-25 REV. B<br>GROUP: 08 - Electrical | Date: | October 18, 2025 | REVISION: | 08-275-25 REV. A |

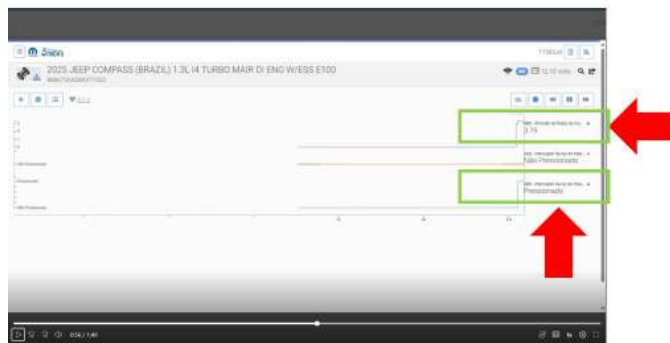
**Fig. 6**

8. Monitor through the graphs the behavior by slowly stepping on the brake pedal, when activating the first stage of the switch the pressure should be up to 4 Bar (H1/ M1 / N4) and 6 Bar (B1) [Fig. 6](#).

Monitor Pressure Readings

9. Is the Bar pressure greater than 4 Bar (H1/ M1 / N4) and 6 Bar (B1) [Fig. 6](#)?
- YES>>> Proceed To Step 10.
  - NO>>> This bulletin has been completed. Use Inspection LOP (08-80-84-90) to close the active RSU.
10. Disconnect the negative battery terminal.

11. Remove the brake pedal switch from its seat by turning it counterclockwise, until it comes off the brake pedal.

12. Position the switch on its seat on the pedal and turn it clockwise, until it is completely fixed (you will notice the click of the lock).
13. Connect the negative battery terminal.
14. Clear DTCs.
15. Start the engine, place the transmission in Park "P" position and deactivate the parking brake.
16. Check the residual brake pressure again [Fig. 7](#) by monitoring through the graphs the behavior by slowly stepping on the brake pedal, when activating the first stage of the switch the pressure should be less than or equal to 4 Bar (H1/ M1 / N4) and 6 Bar (B1) or less than or equal to 6 Bar (Renegade).

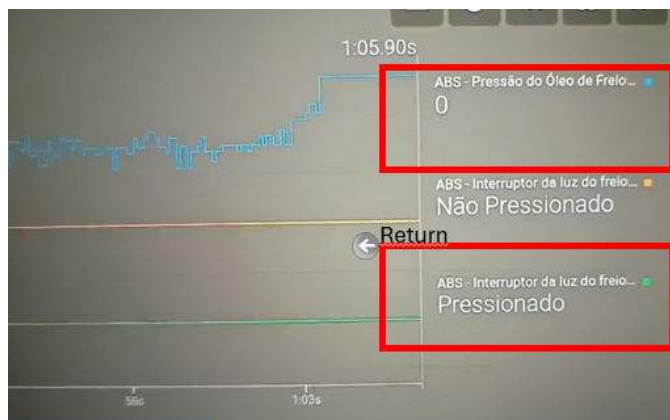
**Fig. 7**

Pressure Readings
