# TECHNICAL SERVICE BULLETIN

## Upper Engine Ticking/Tapping Noise At Idle

**25-2572**

25 November  
2025

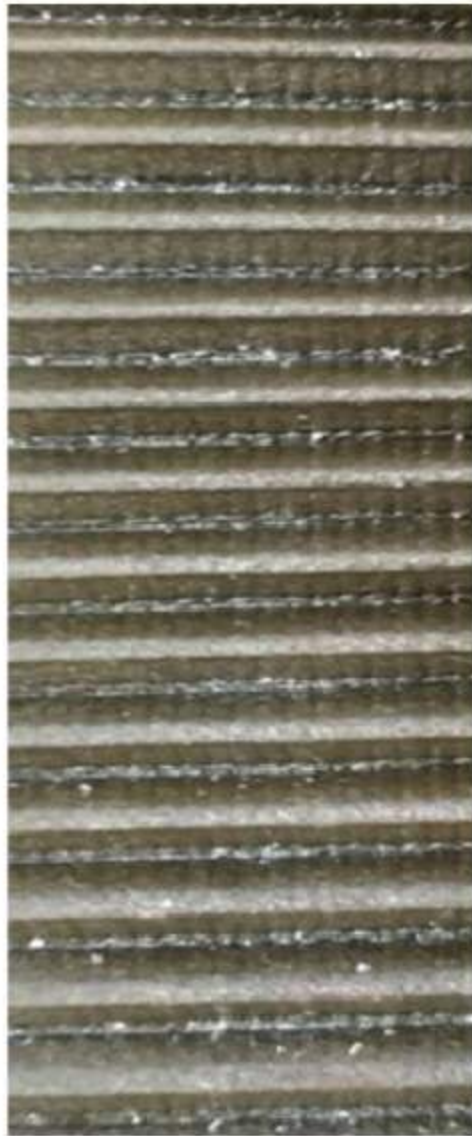
Figure 1

- Open the oil filter assembly and separate the oil filter element to expand out on a flat surface. Refer to WSM, Section 303-00, General Procedures for Oil Filter Inspection. Is an excessive amount of metal debris present in the oil filter? (Figure 1)

- (1). Yes - replace engine long block assembly. Refer to WSM, Section 303-01 for engine removal and installation. Repair is complete.
  - (2). No - proceed to Step 7.
