# Technical Service Bulletin

CHECK ENGINE LIGHT ON WITH DTC P0126:00

Bulletin No.: 01-003/25

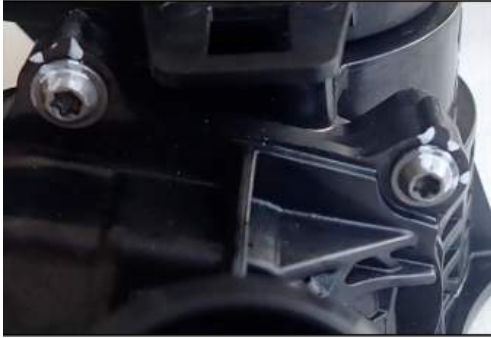
**Marking Example 1:** Draw marking lines over the screws and the thermostat cover as shown above.
