| <b>Subject:</b><br><br><b>"TCU MALFUNCTION. HAVE THE VEHICLE INSPECTED."<br/>MESSAGE AND DTC B1252:87 AND U0198:00 STORED</b> | <b>Service Alert No.: SA-060/25</b> |
| | <b>Last Issued : 12/16/2025</b> |

2025-2026 Mazda3  
2025-2026 CX-30  
2025-2026 CX-50  
2025-2026 CX-50 HYBRID  
2025-2026 CX-70  
2025-2026 CX-90

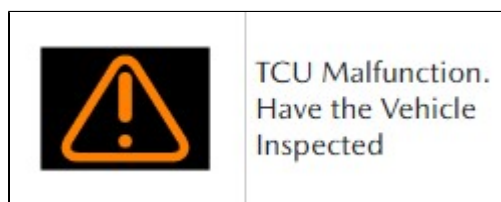
Some customers may experience a message "TCU Malfunction. Have the Vehicle Inspected" in the instrument cluster.

The following DTC's may be stored:

- B1252:87-8B:TCU - COMMUNICATION ERROR WITH CONNECTIVITY MASTER UNIT (CMU)
- U0198:00-03:CMU - COMMUNICATION ERROR WITH EMERGENCY CALL UNIT/TELEMATICS COMMUNICATION UNIT

1. Verify the concern.
2. Check if the following DTCs are stored:

3. Check for electrical devices in the vehicle such as a device connected to USB hub, Dash Cam, Insurance Device, FasTrak.....ect.

4. Remove customer device.

5. Clear the DTC(s).

6. Perform **Diagnostic Assist Function:**

- **YES:** Go to next step.
- **NO:** Replace USB Hub, then go to next step.
