## Condition

### Applicable Vehicles

| Model(s) | Year | Eng. Code | Trans. Code | VIN Range From | VIN Range To |
|---|---|---|---|---|---|
| Passat | 2012-2014 | 2.0L TDI<br>(CKRA) | All | All | All |

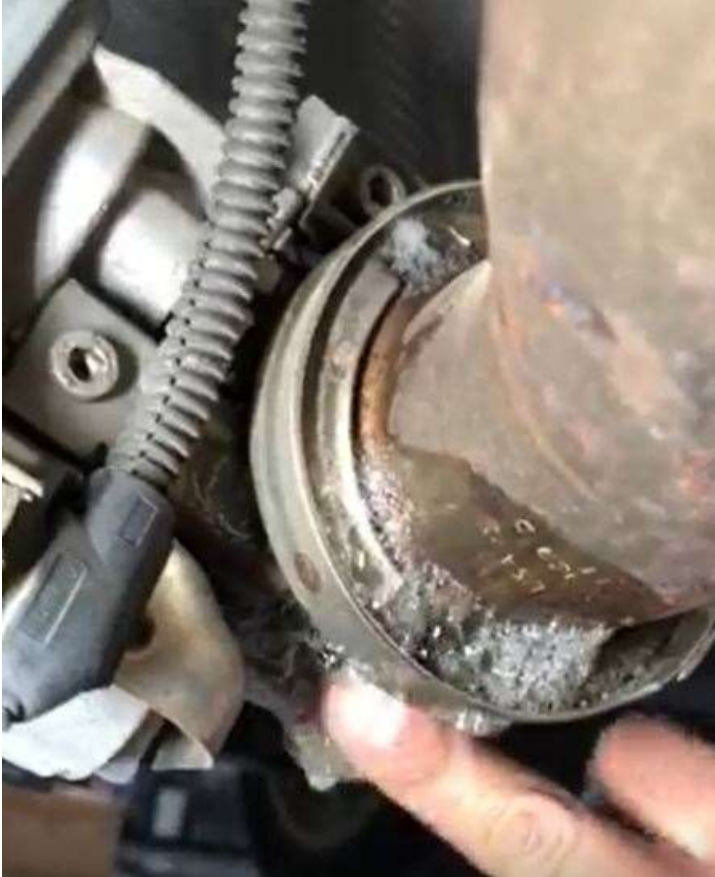
Figure 1. Example of exhaust leak at exhaust flap.

- 2.) If the "AF" index sensor is already installed on the vehicle, do not replace sensor on the first repair visit. Verify **wiring by referring to Safety Recall 23T3** and there are no leaks in the exhaust system upstream of the NOx Sensor, which may be contributing to erroneous sensor values. The VAS1687 tool is useful in pressurizing the exhaust, and a soapy water mixture works well to find leak areas. Pay close attention to the exhaust pipe connections on the exhaust flap for the low pressure EGR system. If leaks are identified, repair them as necessary. If the exhaust is verified to be leak free and an "AF" sensor variant is installed, replace the sensor if directed by GFF.
