# Service Bulletin

Bulletin No.: 22-NA-248

**Subject:** HVAC Heat Intermittently Inoperative, DTCs B2B05 and/or B2B06 Set

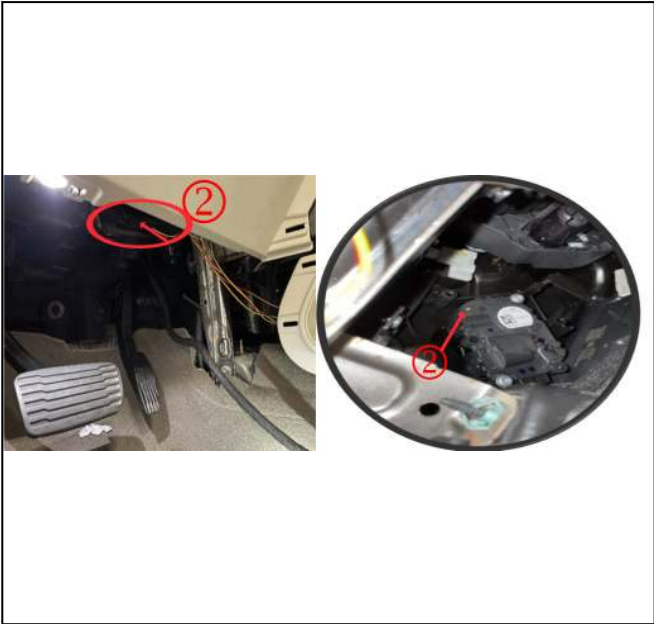
6213261

Visually inspect the right-side temperature valve actuator (2) and the left-side temperature valve actuator (1) for a yellow dot, as shown in the pictures above, that indicates the parts were manually re-flashed. If the yellow dot is present, replace the temperature valve actuator.

Refer to *Temperature Valve Actuator Replacement* in SI.
