## Technical Service Bulletin (TSB)

### Replace K1 Clutch / Input Shaft Assembly

| REFERENCE: | TSB: 21-039-26<br>GROUP: 21 - Transmission and Transfer Case | Date: | May 8, 2026 | REVISION: | 21-051-24 |
| CAUSE: | K1 clutch manufacturing issue that results in a loss of torque transfer for lower gears 1, 2, 3 and 4. | | | | |

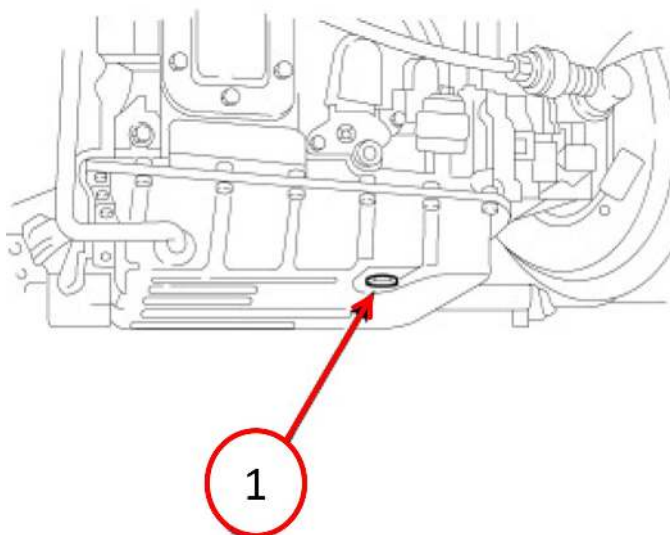
**Fig. 1**  
Oil Pan Drain Plug

5. Remove oil pan drain plug [Fig. 1](#) and drain fluid from transmission pan. **DISCARD** the drain plug gasket.

1 - Transmission Oil Drain Plug

35. Using a **NEW** gasket, install the transmission oil pan drain plug [Fig. 1](#).

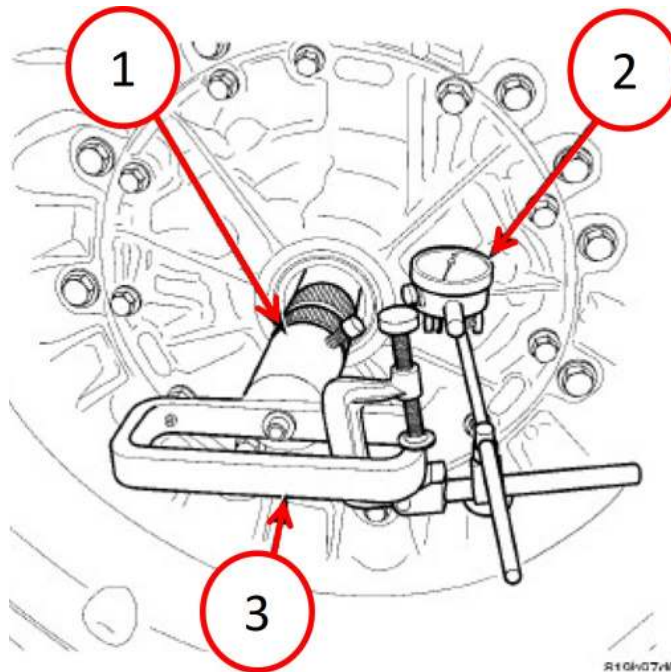
**Fig. 3**  
Recording The Input Shaft End-Play

**NOTE:** Gear train end play is a critical pre-disassembly check to help determine the condition of the transmission. An end play reading greater than specification (larger gap) indicates that a bearing or thrust plate is either missing, worn or has disintegrated, in which case there will be debris found in the transmission oil pan.

7. Using special tools Adapter Socket, End Play 8266-22 and the handle from End-Play Tool Set 8266B and Dial Indicator C-3339A, measure and record the input shaft end-play [Fig. 3](#).

1 - 8266-22

2 - 8266B

3 - C-3339A

26. Install the Dial Indicator Set C-3339A with Input Shaft Spline Socket, End Play 8266-22 and Handle 8266-8, to check the input shaft end-play clearance. The input shaft end-play clearance for both 2WD and 4WD is 0.50 - 0.90 mm (0.019 - 0.035 in.). **If the clearance is not within tolerance you must choose the correct selectable thrust bearing race.**

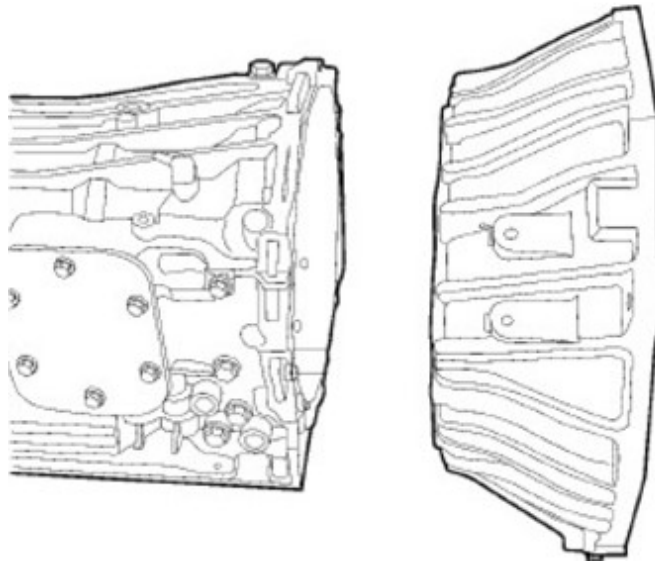
**Fig. 4**  
Torque Converter Housing And Transmission Case

8. Remove the bolts securing the torque converter housing to the transmission case and remove the housing [Fig. 4](#).

29. Install the torque converter housing to the transmission case.

30. Install the torque converter housing bolts and tighten to 64 N·m (47 ft. lbs.).

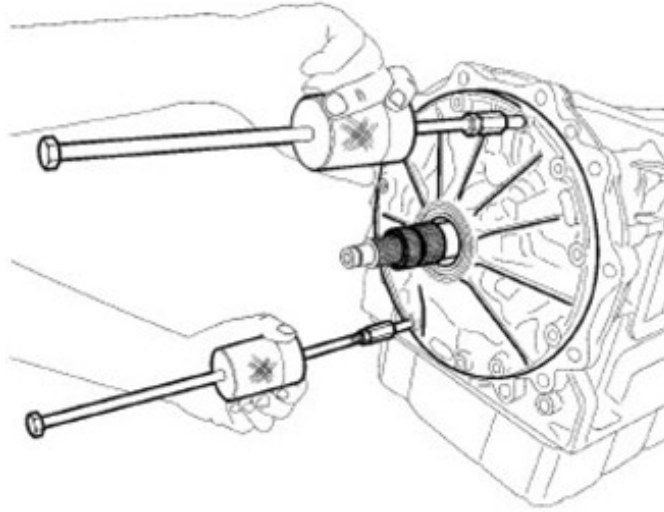
**Fig. 5**

9. Remove the bolts securing the oil pump to the transmission case and use Slide Hammers C-3752 with Adapters 9981 to remove the oil pump assembly from the transmission spline [Fig. 5](#).

Slide Hammers C-3752 And 9981 Adapters

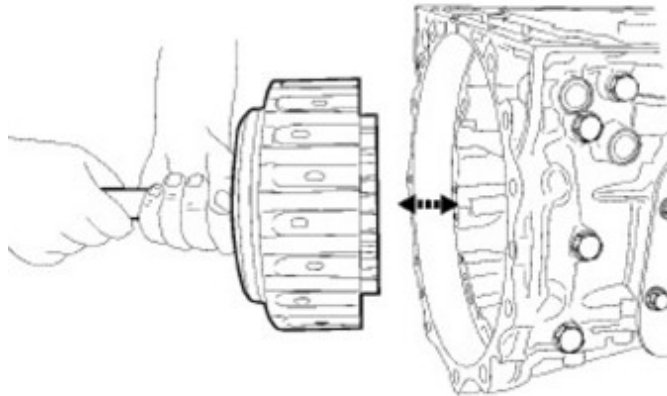
**Fig. 6**

10. Remove the input shaft assembly with the K1 and K2 clutch assemblies attached [Fig. 6](#).

**NOTE: If the K1 snap ring has become dislodged, the K1 clutch assembly will not come out as a complete unit.**

K1 And K2 Clutch Assemblies

21. Install the K2 clutch assembly and the K1 clutch/input shaft assembly into the transmission case [Fig. 6](#).

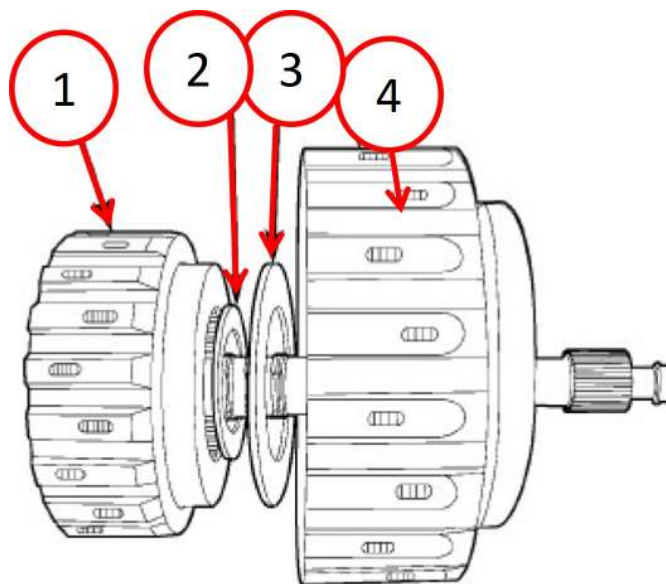
**Fig. 7**  
K1 And K2 Clutch Assemblies

11. Remove the K2 clutch assembly and the selectable input shaft end-play thrust bearing number one and thrust washer from the K1 clutch/input shaft assembly [Fig. 7](#).

- 1 - K1 Clutch/Input Shaft Assembly
  - 2 - Thrust Bearing Number One
  - 3 - Thrust Washer
  - 4 - K2 Clutch Assembly
-

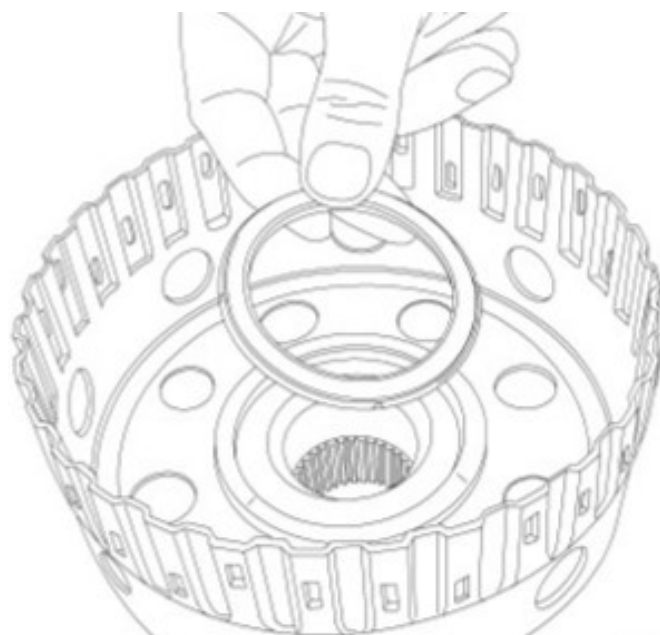
**Fig. 11**

16. Lubricate with trans jel or petroleum jelly and install K2 thrust bearing number three [Fig. 12](#).

K2 Hub Thrust Bearing Number Three

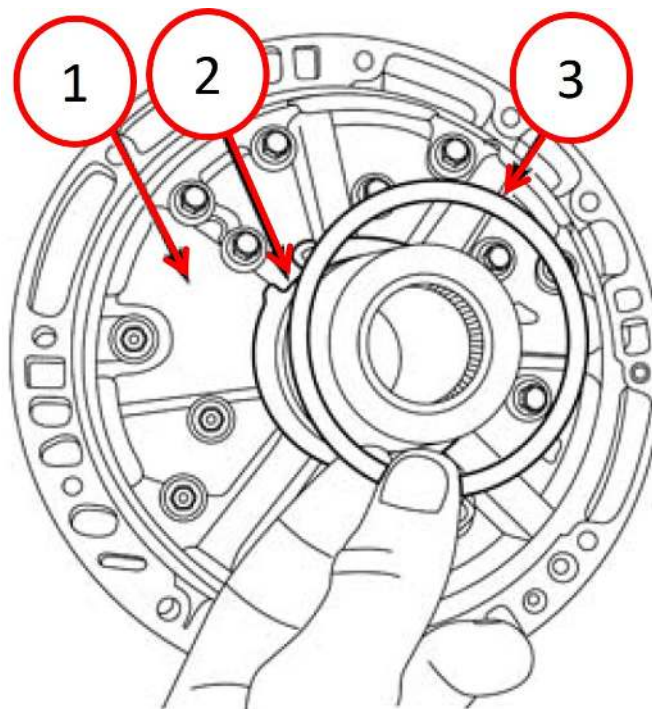
**Fig. 12**

22. Lubricate with trans jel or petroleum jelly and install the nylon thrust washer onto the oil pump [Fig. 12](#).

**NOTE: The nylon thrust washer is keyed to the oil pump [Fig. 12](#).**

**NOTE: Two pin punches inserted through the oil pump mounting holes will aid in the installation of the oil pump [Fig. 12](#).**

Oil Pump Assembly

- 1 - Oil Pump
- 2 - Nylon Thrust Washer
- 3 - Input Shaft Seal Ring
