## TECHNICAL SERVICE BULLETIN

### Illuminated MIL With DTCs P0300/P0316 Stored In The PCM During A Cold Start

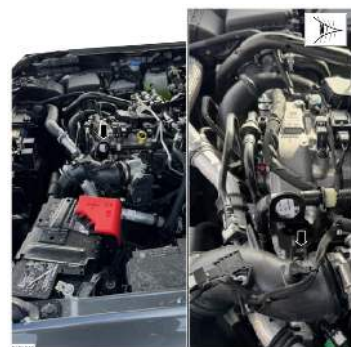
Figure 1

2. Inspect the cylinder head for the "EBN7A" manufacturing code stamped on the cylinder head located under the driver side factory engine lift eye as shown in Figure 1. Does the cylinder head have the "EBN7A" manufacturing code? (Figures 1-2).

(1) Yes - proceed to Step 3.

3. Remove the cylinder head. Refer to [WSM](#), Section 303-01 > Engine > 2.3L EcoBoost > Removal and Installation > Cylinder head.

4. Remove the required parts from the old cylinder head. Refer to [WSM](#), Section 303-01 > Disassembly and Assembly of Subassemblies > Cylinder Head and perform disassembly Steps 1-22.

5. Transfer the parts to the new cylinder head. Refer to [WSM](#), Section 303-01 > Disassembly and Assembly of Subassemblies > Cylinder Head and perform assembly Steps 4-25.

6. Install the new cylinder head. Refer to [WSM](#), Section 303-01 > Engine > 2.3L EcoBoost > Removal and Installation > Cylinder Head.
