Model 907 with all-wheel drive (A4M) – All-wheel drive inoperative

| Topic number | LI33.30-N-080795 |
| Function group | 33.30 - Final drive, differential, drive shaft |
| Validity | Model 907 with A4M special equipment – All-Wheel Drive Torque on Demand |

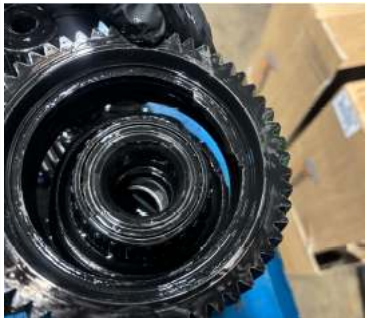
| Attachments | |
|---|---|
| <a href="#">Bild1.png</a><br> | Figure 1 |

An internal failure of the front axle differential may result in loss of torque transfer to the front wheels. In some cases, a fracture of the weld between the crown gear and differential housing may be present. (figure 1)

Replace the front axle differential in accordance with:

AR33.30-D-0525TSY – Replace Front Axle Differential.
