# Technical Service Bulletin

**SEAT WARMER DOES NOT OPERATE WHEN TURNING IGNITION ON WHILE CABIN TEMPERATURE AND/OR SEAT IS WARM**

**Bulletin No.: 09-016/26**

**Last Issued : 07/01/2026**

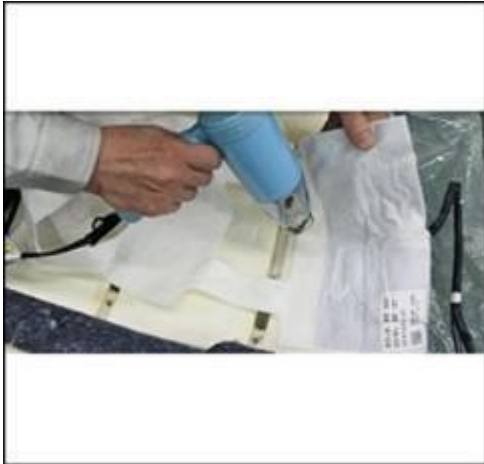
- a. Remove the heater mat gently while using a hair dryer or an iron to warm up the adhesive parts (1).

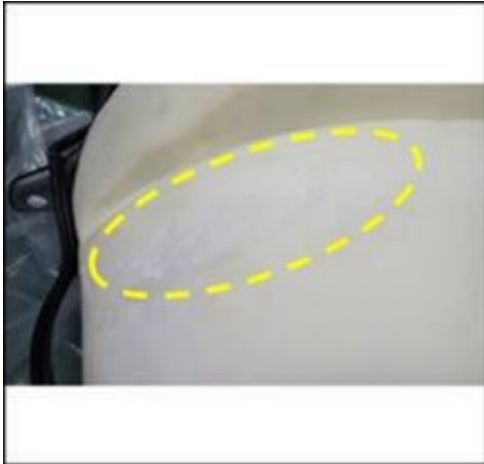
**NOTE:** If the adhesive surface is not warmed up sufficiently, the urethane pad may be damaged (example image below).

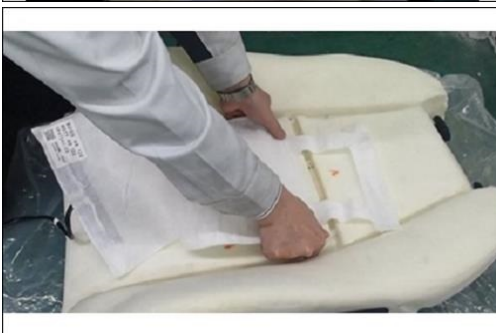
**NOTE:** Location of the markings of the urethane pad

c. Remove the three release papers on the seat warmer unit, and then apply it to the urethane pad according to the markings on the pad (Refer to the procedure below).

**NOTE:** Align with the seat warmer and the markings on the urethane pad.
