# Preliminary Information

## PIC6399 Diagnostic Tip - Service Keyless Start message with B1446 SYM13 Interior Keyless Entry Antenna 3 High Signal

| Brand: | Model: | Model Years: | VIN: | | Engine: | Transmissions: |
|---|---|---|---|---|---|---|
| Cadillac | CT5 | 2020 | ALL | ALL | ALL | ALL |

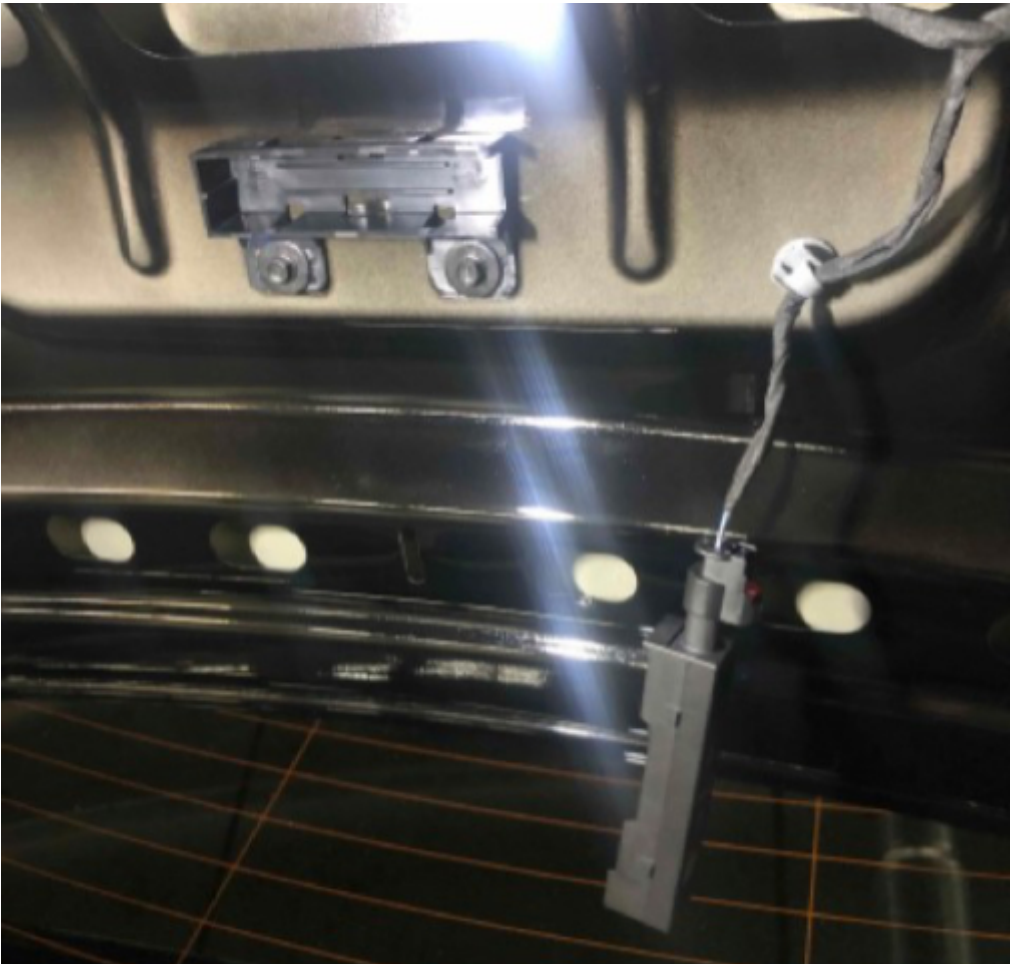
| Cause | The T10E Keyless Entry Antenna - Rear Compartment may not be mounted in its bracket. |

Inspect the T10E Keyless Entry Antenna - Rear Compartment for being loose or having fallen out of the bracket.
