## PIT5487F Service Park Assist/Camera/Cruise/ and/or Front Park/Turn/Cornering Light Inop Blown Fuses (Front Fascia/Bumper Harness Chaffing)

| Brand: | Model: | Model Years: | VIN: | | Engine: | Transmissions: |
|---|---|---|---|---|---|---|
| Cadillac | Escalade Models | 2015 - 2020 | All | All | All | All |

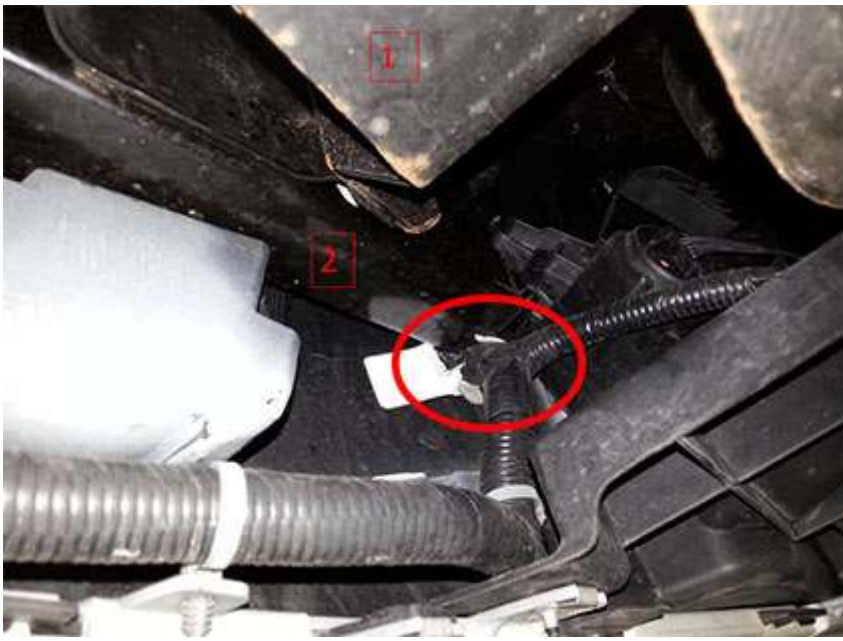
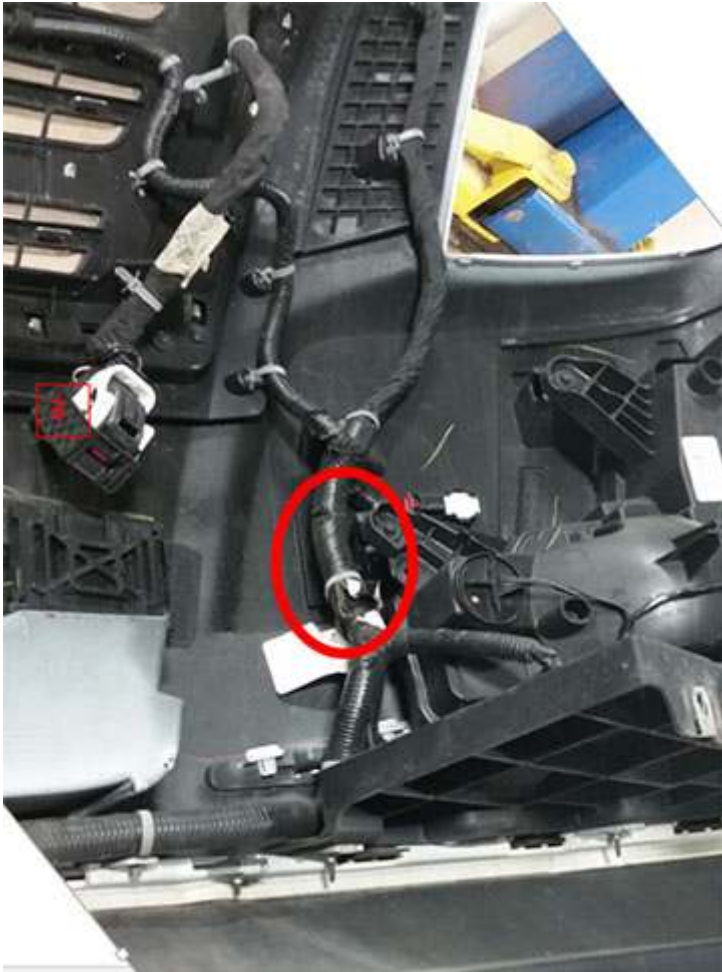
These concerns could be caused by the front fascia/bumper harness shorted at the end of the right front bumper bar (2), as shown below.

- 1. Right front frame rail
- 2. Right side of front bumper bar
- 3. X100 inline connector

The front fascia may need to be removed to make repairs to the wiring harness if any damage is found. After repairing any damaged circuits, reinstall the front fascia and pay close attention to reroute the wiring harness behind the front bumper bar and secure with a zip tie to the fascia, as shown below. This will prevent it from damage again in the future.
