| <b>HYUNDAI</b><br><b>Technical Service Bulletin</b> | GROUP<br>ENGINE | NUMBER<br>20-EM-002H |
| | DATE<br>JULY, 2020 | MODEL<br>ELANTRA (ADa) |
| <b>SUBJECT:</b> | ENGINE THERMOSTAT REPLACEMENT DTC P0128 / P2181 | |

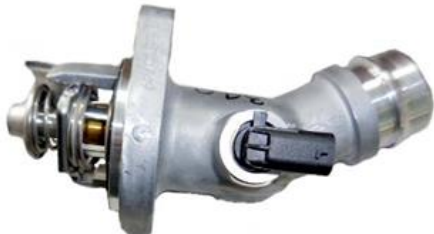
| MODEL | PART NUMBER | DESCRIPTION | PHOTO |
|---|---|---|---|
| Elantra (ADa) | 25500-2E085-QQH | Thermostat | |
