# Service Alert

**CHECK ENGINE LIGHT ON WITH P3400**

**Service Alert No.:** SA-061/20

2018-2020 Mazda6  
2018-2020 CX-5  
2019-2020 Mazda3  
2020 CX-30

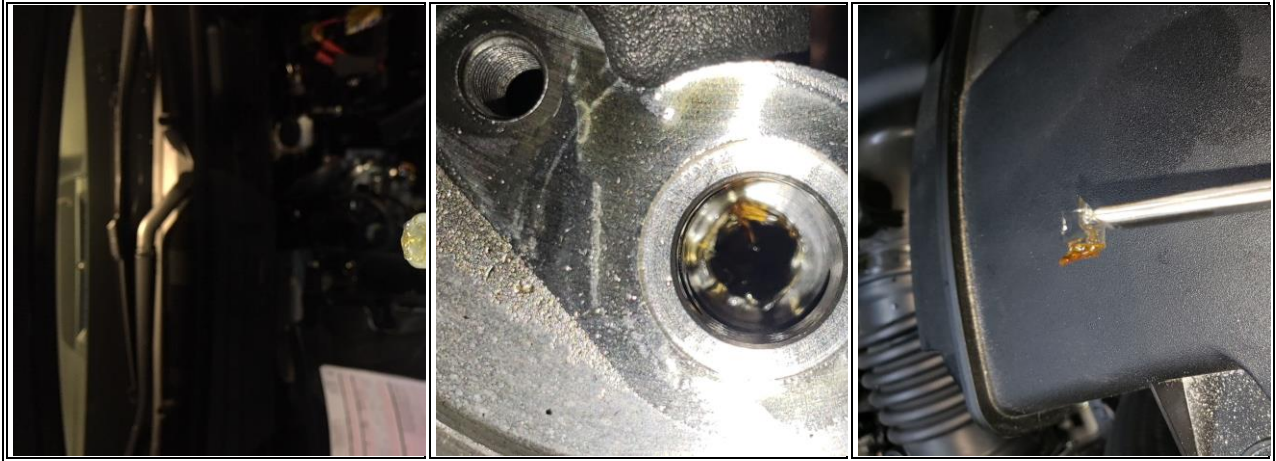
If you receive a customer concern about the CHECK IN light coming on and DTC P3400 (cylinder deactivation system malfunction) stored, the cylinder deactivation oil control valve may be plugged with plastic debris from the oil filter wrapper. The debris may enter the center of the oil filter when poking a hole in the filter wrapper during removal, and then travel through the engine and plug the cylinder deactivation oil control valve.

1. Verify customer concern.
2. Remove the front and rear cylinder deactivation oil control valves and inspect the oil control valves and cylinder head port for contamination or debris (see photo).

- **YES:** Inspect the oil passage for debris and clear the passage if debris is found. A vacuum device such as a brake bleeder may be helpful in removing the debris.
  - If the OCV tip filter is damaged, replace the cylinder deactivation OCV.
- **NO:** Proceed with a normal diagnosis for DTC P3400 on MGSS.
