## Product Update: 2017 Civic Type R Turbocharger Control Solenoid Valve Circuit

Supersedes 18-044, dated June 26, 2018; see REVISION SUMMARY

### AFFECTED VEHICLES

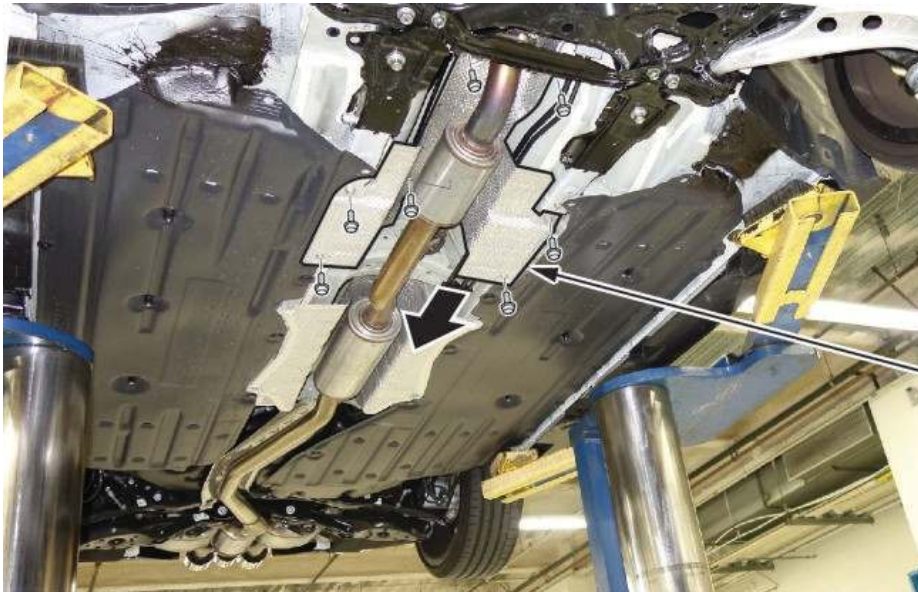
1. Disconnect the 12-volt battery. Refer to the service information.
2. Raise the vehicle on a lift.
3. Remove the following parts from underneath the vehicle. Refer to the service information.
  - Engine undercover
  - Unbolt and slide back the heat shield above exhaust pipe B

**HEAT SHIELD**  
Slide rearward.

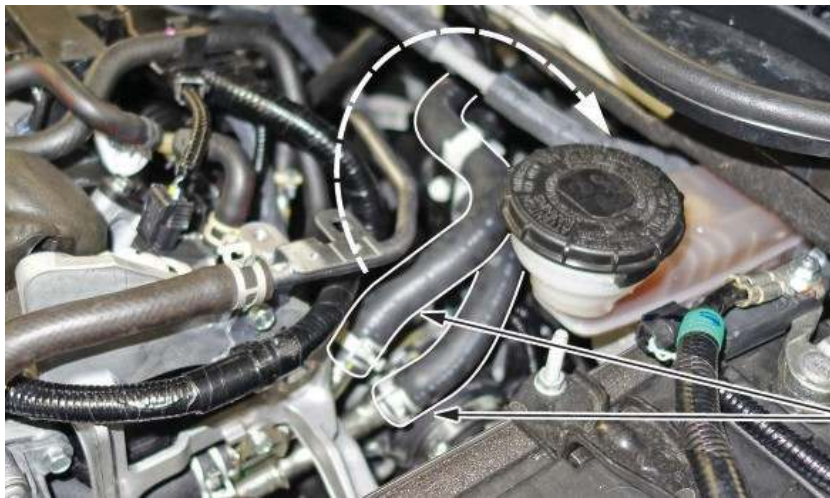
5. Lower the vehicle.
6. Remove the following parts at the engine compartment. Refer to the service information.
  - Engine cover
  - Engine air box assembly
  - Battery and battery tray
  - ECU
  - Charge air cooler and bracket
  - Cooling system bypass heater hoses

Carefully remove the heater hoses and cap off to avoid coolant loss.

**HEATER HOSES**  
Disconnect and swing up  
and out of the way.
