## SERVICE BULLETIN

EC14-003

### 2013 – 2014 SENTRA; MIL ON WITH DTC P0448

**APPLIED VEHICLES:** 2013 – 2014 Sentra (B17)

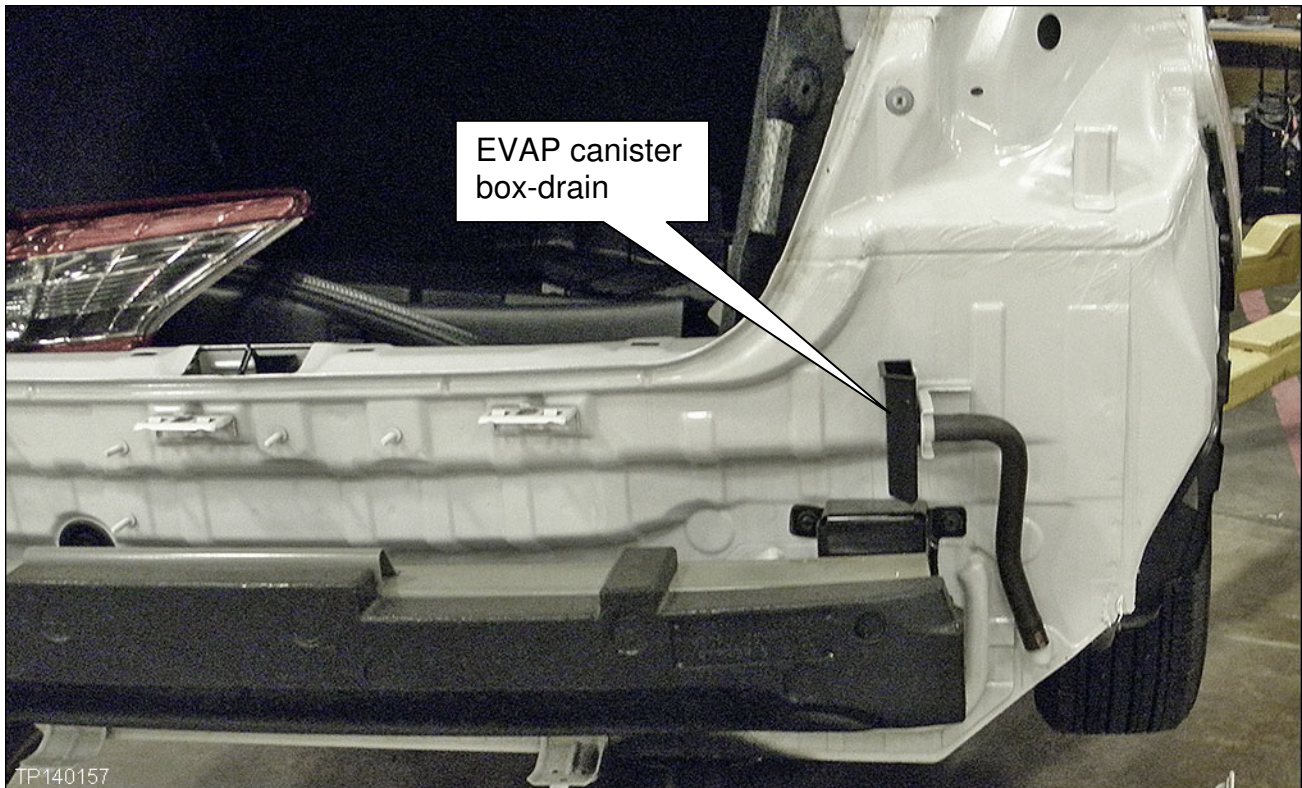
Figure 1

1. Remove the rear bumper fascia.
  - Refer to the Electronic Service Manual (ESM), section EXT-Exterior, for removal information.
2. Locate the EVAP canister box-drain.
  - The EVAP canister box-drain is located on the passenger side just below the tail-light area.

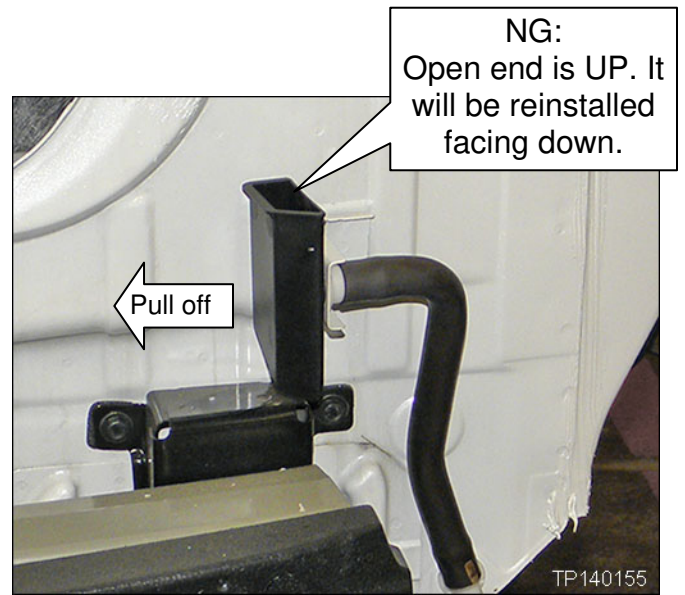
Figure 2

3. Remove the EVAP canister box-drain.

- Pull to unsnap and remove.

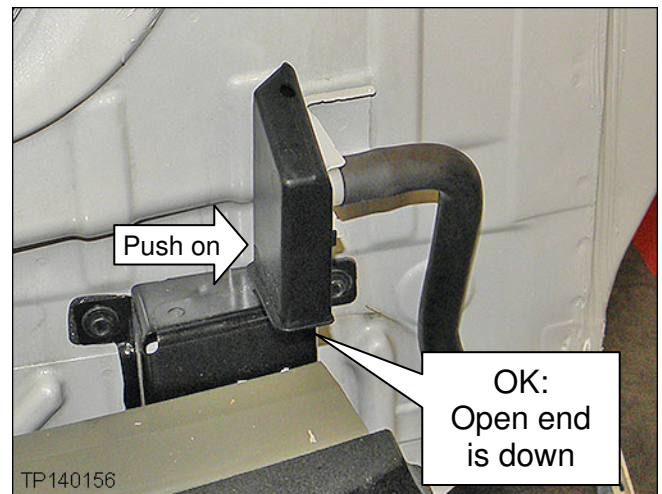
Figure 3

5. Re-install the EVAP canister box-drain with the **open end down** as shown in Figure 3.

4. Clean any dirt, ice, or debris from inside the box-drain.

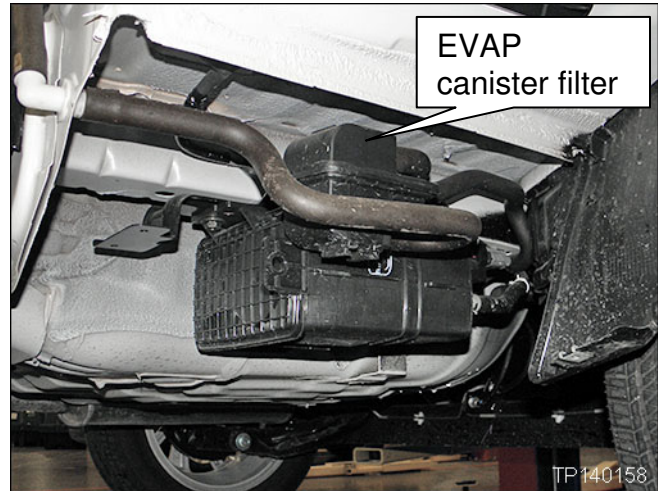
- EVAP canister filter for 2014 Sentra is shown in Figure 4, 2013 Sentra is similar.
- Figure 4 shows the canister with the bumper fascia removed.

6. Remove the EVAP canister filter:

- Refer to Figure 4, and Figures 5 and 6 on the following pages.

7. Empty water from the EVAP canister filter.

8. Re-install the EVAP canister filter.

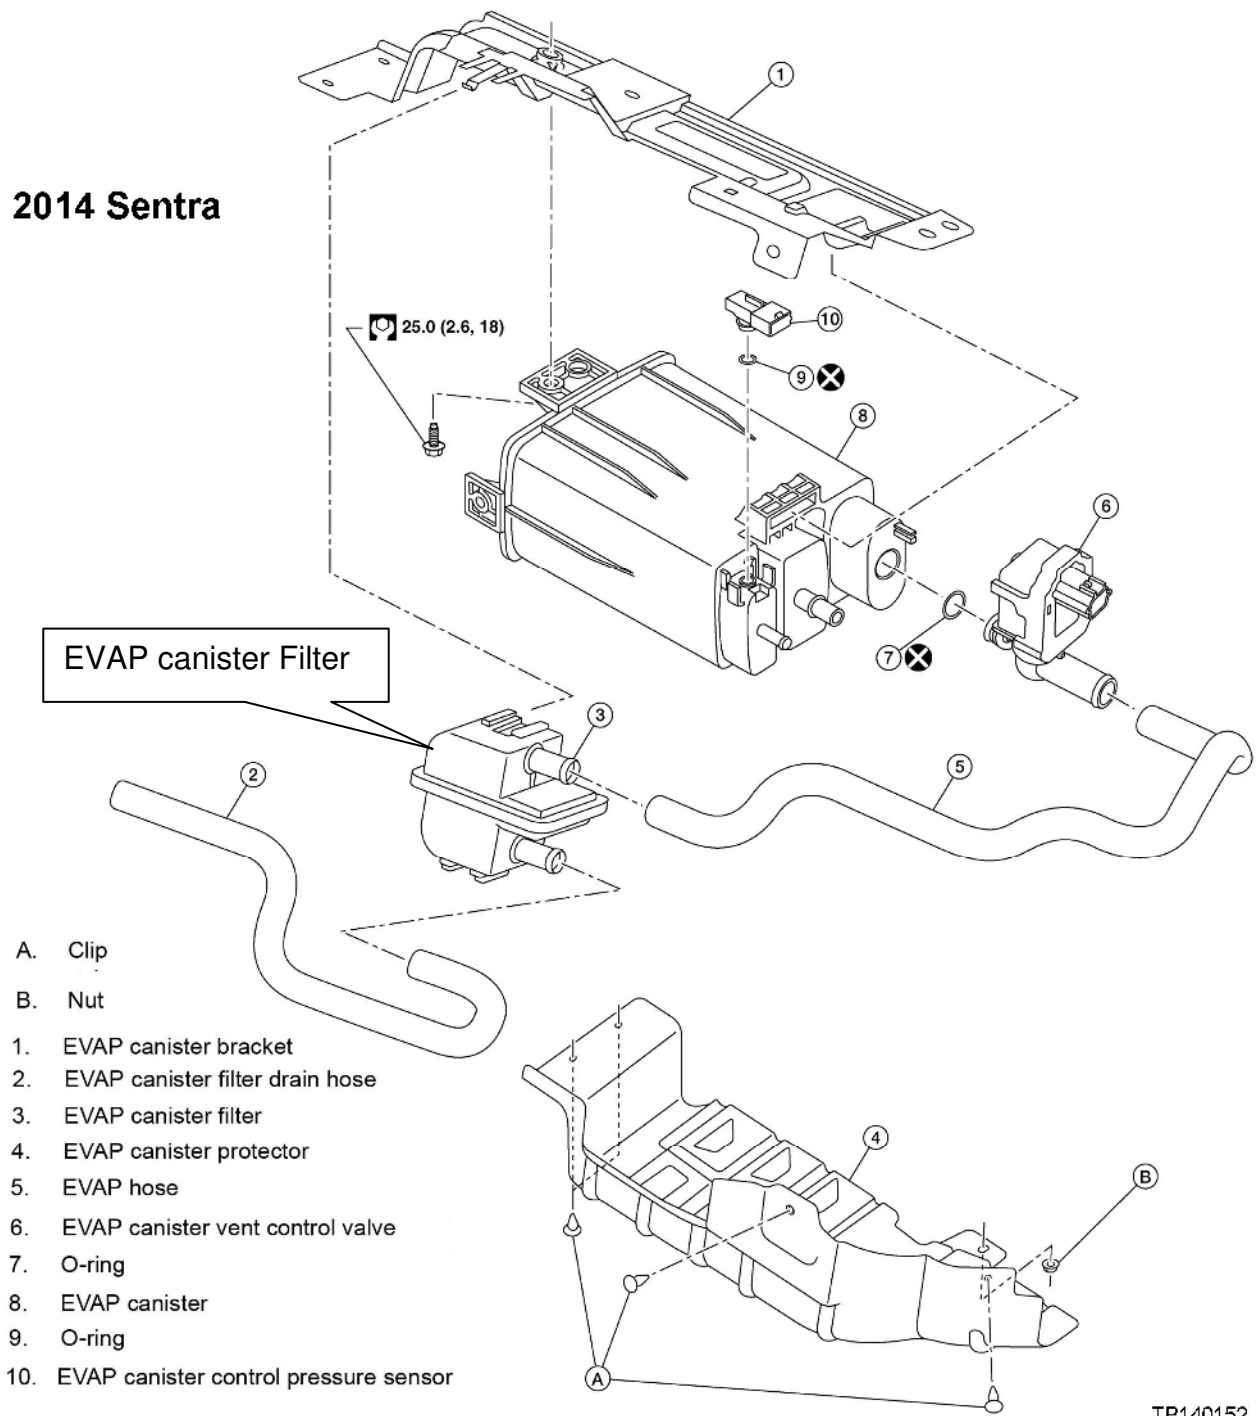
Figure 6

## 2014 Sentra
