## PIT4573E No Crank With DTC P1AAB, P1AAC, P1AAD, and/or P1AAE

| Brand: | Model: | Model Years: | VIN: | | Engine: | Transmissions: |
|---|---|---|---|---|---|---|
| Chevrolet | Silverado | 2004 - 2007 | All | All | All | All |
| GMC | Sierra | 2004 - 2007 | All | All | All | All |

with RPO HP2

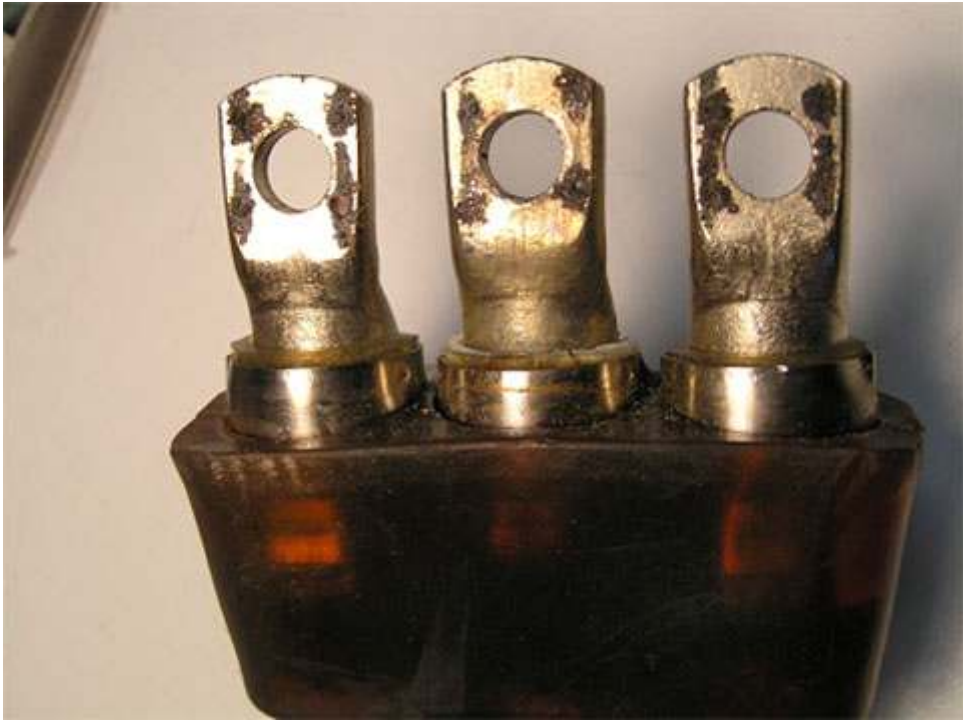
A visual inspection for arcing at the cable to stator connections must be performed first by removing the cables from the stator. If there are signs of arcing, replace both components. While replacing the stator and cables remove part of the under hood cowl wall insulation mat in the area that the 3 phase cables are routed.

**This is signs of pitting/arching. These should be replaced. Minor pitting can be cleaned up and the cables reused.**

**Even if there is no arcing, the stator still should be replaced before the SGCM. If the concern is still present after the stator and/or cables have been replaced retest them for a short to ground, open between the phases and there should be less than 1 ohm of resistance between the phases. If all test good replace the SGCM.**
