## Warranty Extension: MIL Comes On with DTCs P0301 Thru P0304

Supersedes 13-079, dated June 13, 2018, to revise the information highlighted in **yellow**.

| Year | Model | Trim | VIN Range |
|---|---|---|---|
| 2010-12 | Crosstour | V6 | Check the iN VIN status for eligibility. |

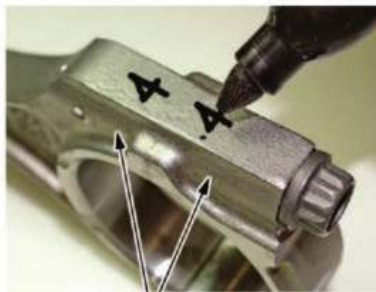
Mark the connecting rod and rod cap with the cylinder number.

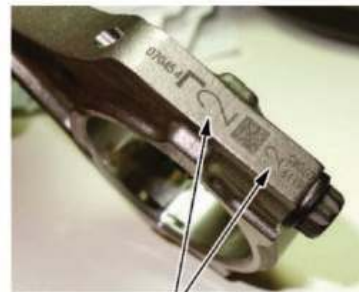
These are manufacturing marks, and do not indicate the cylinder number.

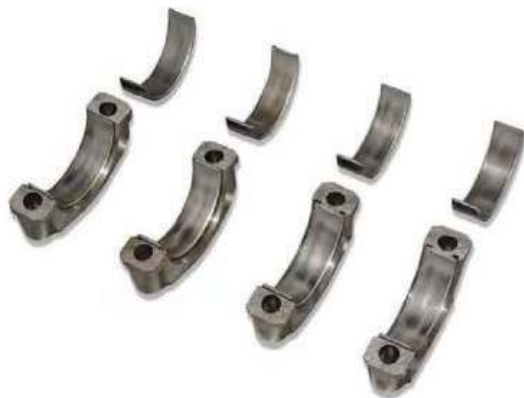
51. Visually inspect all the connecting rod bearing for signs of damage.

- If your fingernail catches on a scratch or groove in the bearing, replace it. Pictured are normal reusable rod bearings after about 35,000 miles. Some discoloration is normal and does not require replacement.
- If the bearings look like they must be replaced, contact your DPSM for authorization.
