## Creaking noises at driver's seat when cornering

| Topic number | LI91.10-P-066971 |
| Validity | W/S205 X/C253 Seat belt buckle creaks on front seat |

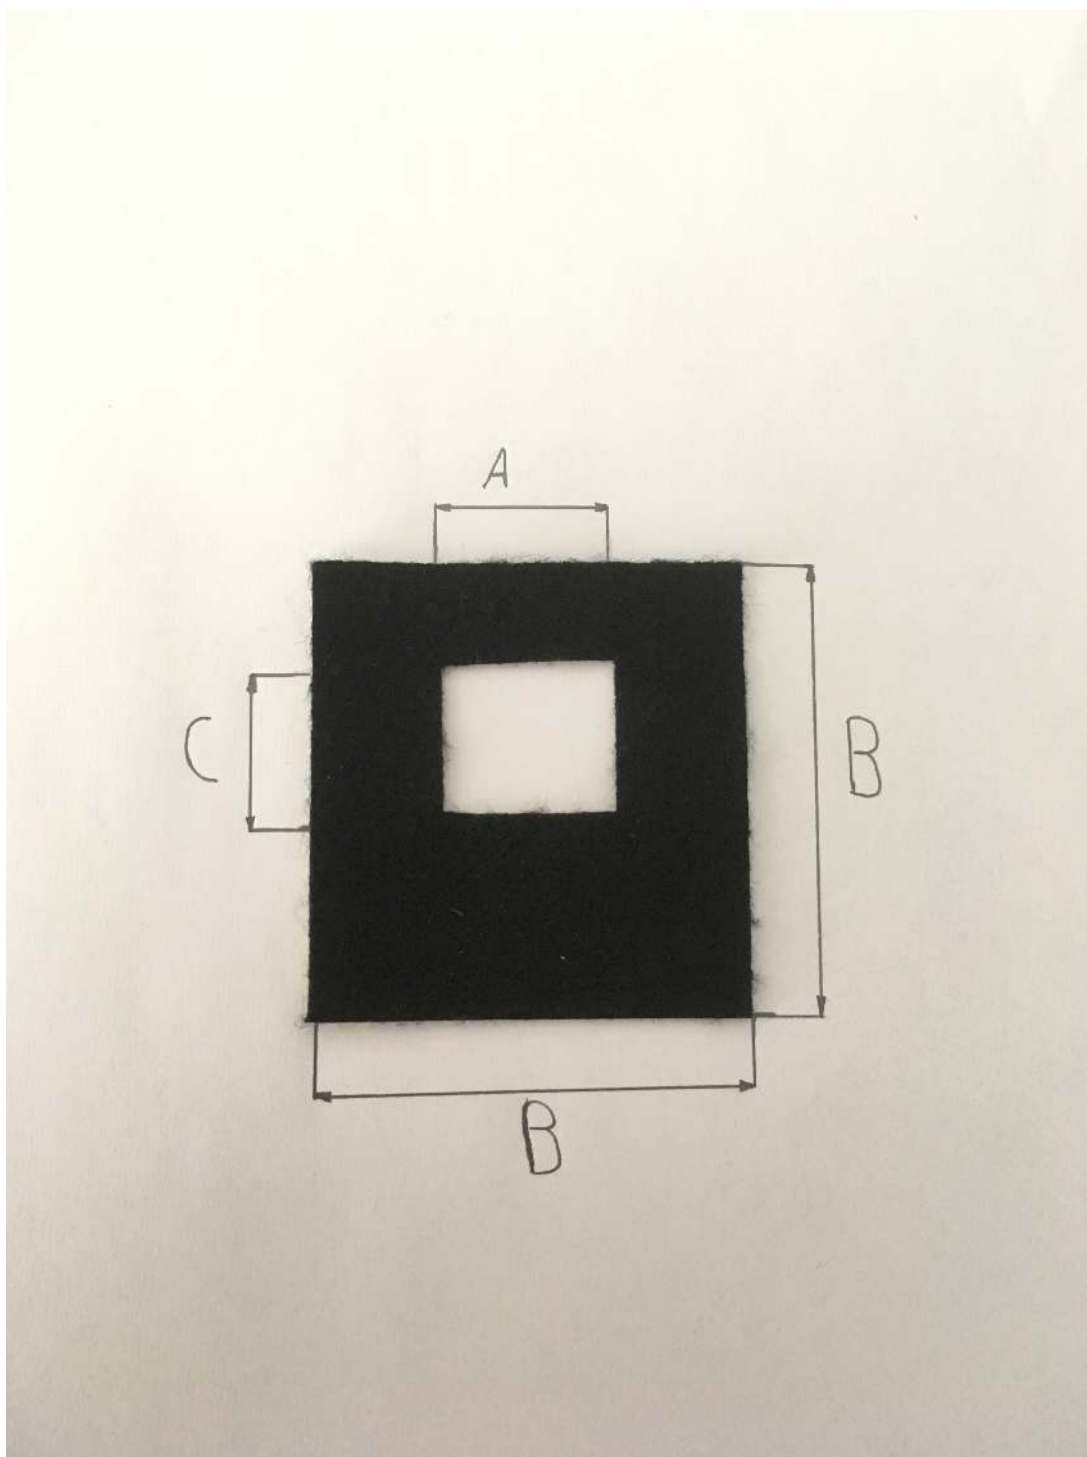
Pic.1.JPG:

| Attachments | |
|---|---|
| Pic.1.JPG | Template with dimensions<br>A: 25 mm<br>B: 65 mm<br>C: 20 mm |

Check whether the seat belt buckle is resting on the seat cover and whether this is causing the noise. If so, line the seat belt buckles on both front seats with felt according to the template (Pic.1).

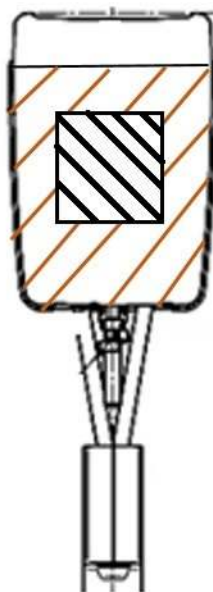
Pic.2.jpg:

| Attachments | |
|---|---|
| Pic.2.jpg | Drawing of position of felt |

Important: The label (Pic.2, area shaded in black) on the seat belt buckle must not be lined with felt. It is not necessary to remove the seat belt buckles.
