NUMBER  
**205 (Rev 1, 04/10/2019)**

DATE  
**April 2019**

## TECHNICAL SERVICE BULLETIN

**SUBJECT:** SERVICE ACTION: WIRING SIGNAL INTERFERENCE  
CHECK & ENGINE NOISE INSPECTION (SA379)

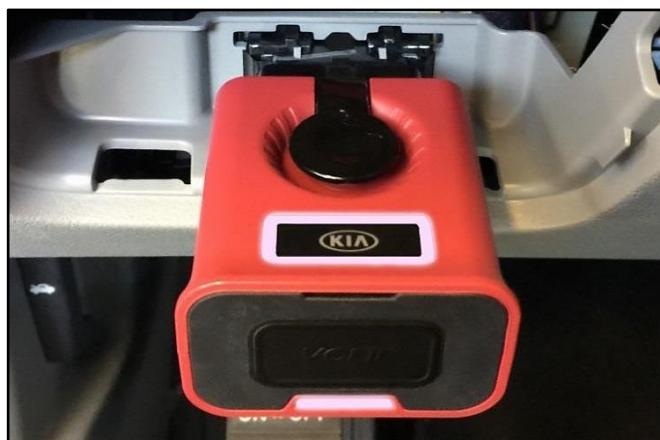
7. Connect the VCI-II to the OBD-II connector and launch the KDS application from the KDS tablet home page.

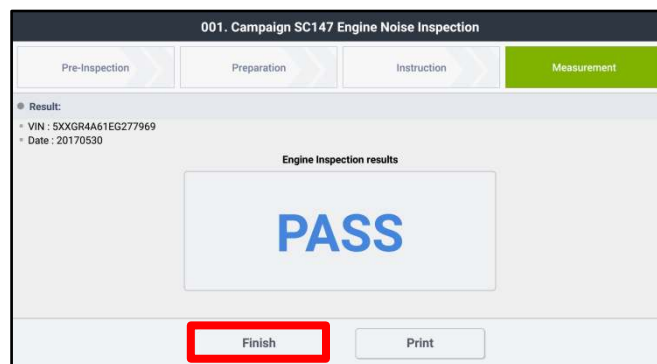
20. Select “Finish” to complete the engine noise inspection. Ensure the KDS is connected to the internet and the “Special Inspection” KDS application is open to automatically submit the results to the Kia Server. To save and/or print the results as PDF, select “Print”.

If the KDS is not connected to the internet, up to five (5) results will stay pending in the queue until the KDS is connected to the internet with the “Special Inspection” application open.
