# Technical Service Bulletin

## 87 Various HVAC system malfunctions, DTC B11AF07 and/or B109207 stored in the climatronic control module

87 19 95 2055257/2 August 8, 2019. Supersedes Technical Service Bulletin Group 87 number 19-90 dated June 5, 2019 for reasons listed below.

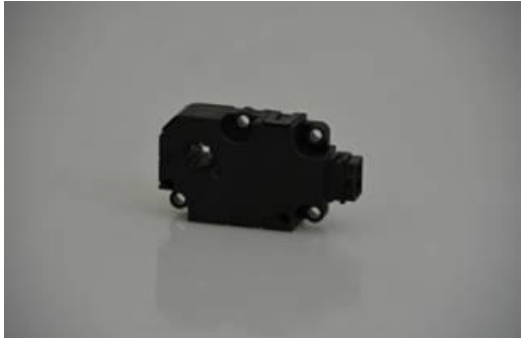
| Always check with your Parts Department and/or ETKA for the latest information and parts bulletins. | | |
|---|---|---|
| 4M0820511A | <br>Motor for adjustment | As necessary |

In cases where the HVAC adjustment motor needs to be replaced, install the **Magna** HVAC adjustment motor with the part number 4M0 820 511 A.
