# Main Body ECU Improvement

| YEAR(S) | MODEL(S) | ADDITIONAL INFORMATION |
| 2012 | Prius C | |

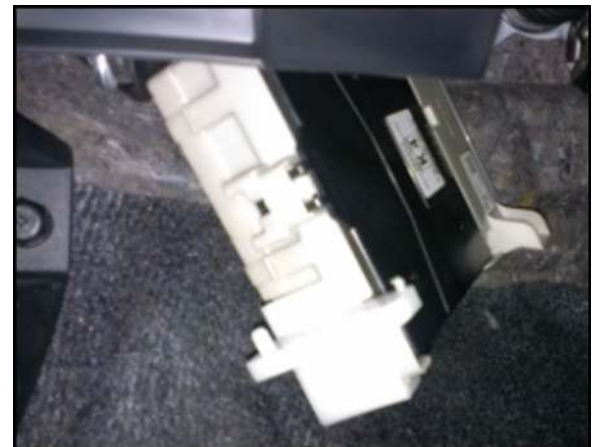
Figure 4.

5. Remove the Main Body ECU.
