# MIL "ON" DTC P0A80 or P0A7F Due to Dust or Debris in the HV Battery Cooling Fan

**Service Category** Engine/Hybrid System

**Section** Hybrid/Battery Control System

| YEAR(S) | MODEL(S) | ADDITIONAL INFORMATION |
|---|---|---|
| 2013 – 2014 | Camry HV | |

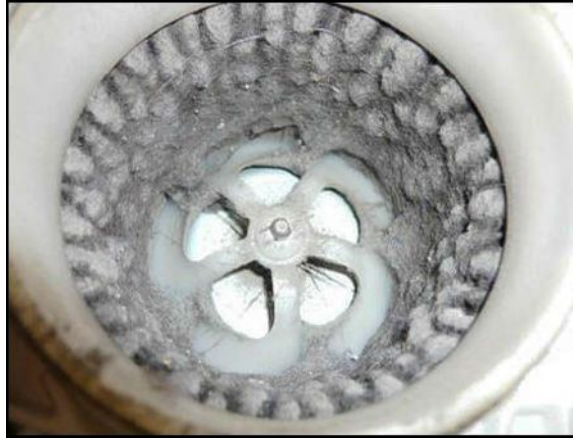
Figure 1.

Is the HV battery cooling fan clogged with dust or debris buildup?

2. Clean any dust, lint, or debris buildup from the HV battery cooling fan blades, module, and ducts using a vacuum and/or compressed air if necessary.

- Do NOT attempt to clean the HV battery cooling fan while it is installed in the vehicle. Doing so may cause dust or debris to enter the HV battery case.
- Secure the fan blades from spinning while cleaning. Spinning the fan blades while cleaning can result in electronic circuit failure due to excessive fan blade speed.

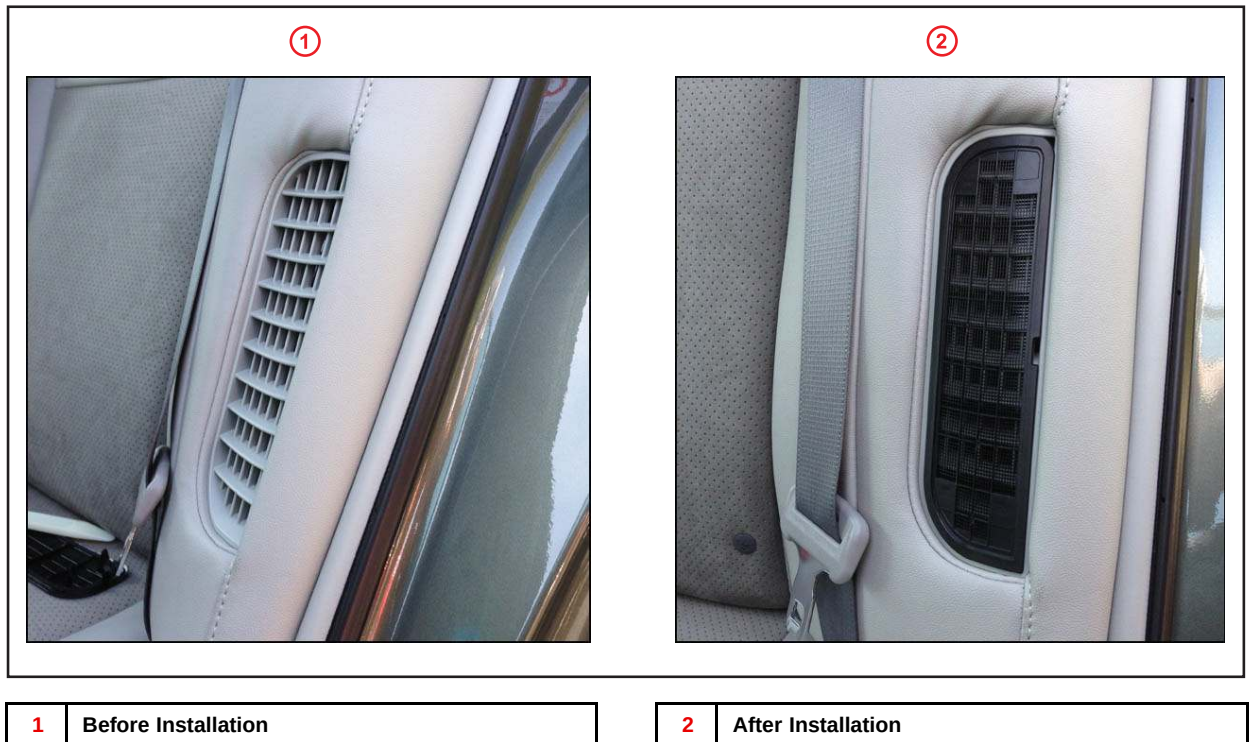
Figure 2.

The filter should be cleaned when dust begins to appear on the surface.

4. Install a new HV Battery Intake Filter No. 1 (P/N G92DH-33020) as shown.

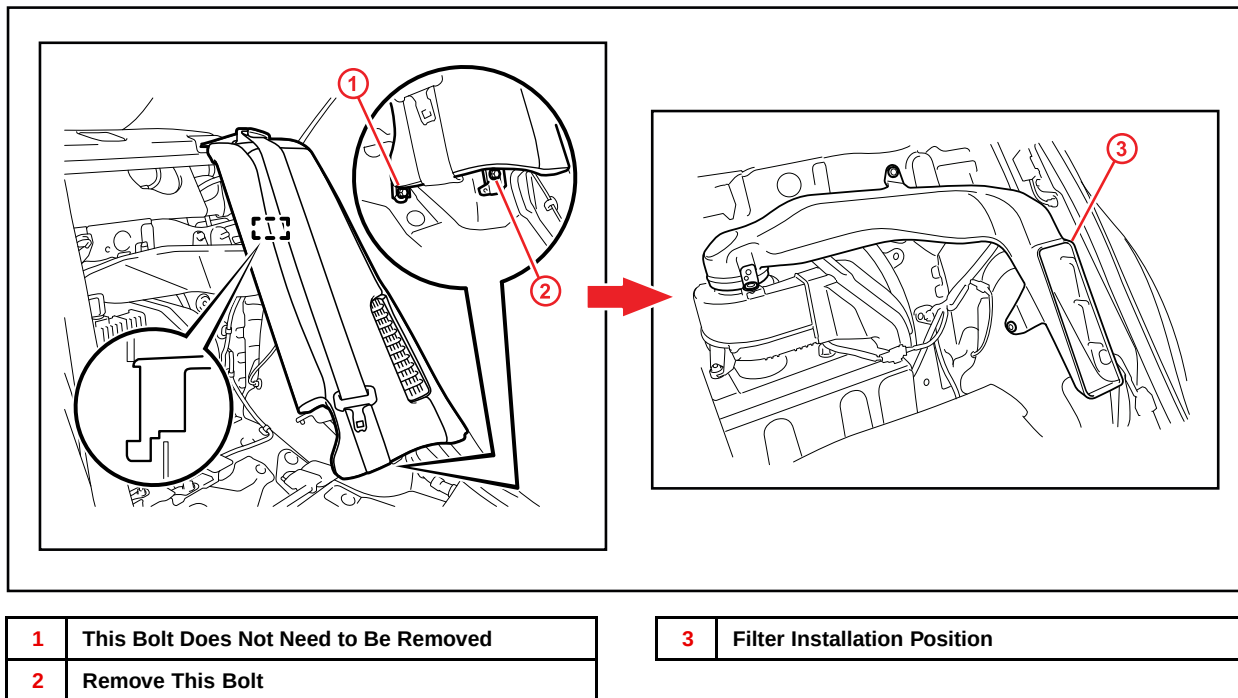
Figure 3.

1. Is the internal filter clogged with dust or debris buildup?

Seatback does NOT need to be removed though it's not shown in the Figure above.

2. Check the physical condition of the internal filter.
  - A. If the filter is damaged, replace the HV Battery Intake Filter No. 1 (P/N G92DH-33040).
  - B. If the filter is physically OK, clean using vacuum and make sure no contaminants enter the HV Battery cooling system including fan.

- Clean the HV battery intake duct No. 1 with vacuum. Do NOT use water or fluid when cleaning.
- Do not use a wire brush or a scrub brush for cleaning the HV Battery Intake Filter No. 1 due to a concern that the brush may damage the part.

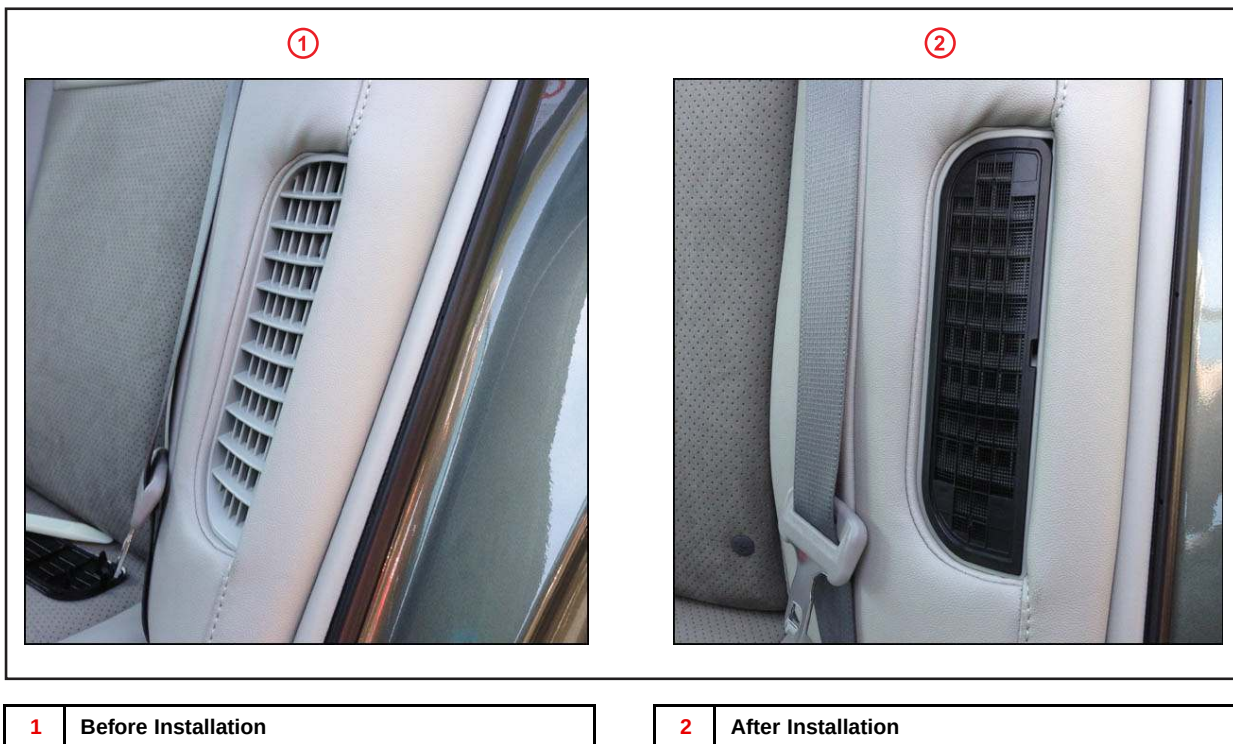
Figure 4.

The filter should be cleaned when dust begins to appear on the surface.

3. Install a new HV Battery Intake Filter No. 1 (P/N G92DH-33020) as shown.
