| <b>HYUNDAI</b><br><b>Technical Service Bulletin</b> | GROUP<br><b>CAMPAIGN</b> | NUMBER<br><b>18-01-012</b> |
| <b>SUBJECT:</b> | ENGINE THERMOSTAT REPLACEMENT P0128<br>(SERVICE CAMPAIGN TLL) | |

***This TSB supersedes TSB 16-01-034-2 with updated service procedure to the engine coolant filling and air bleeding steps.***

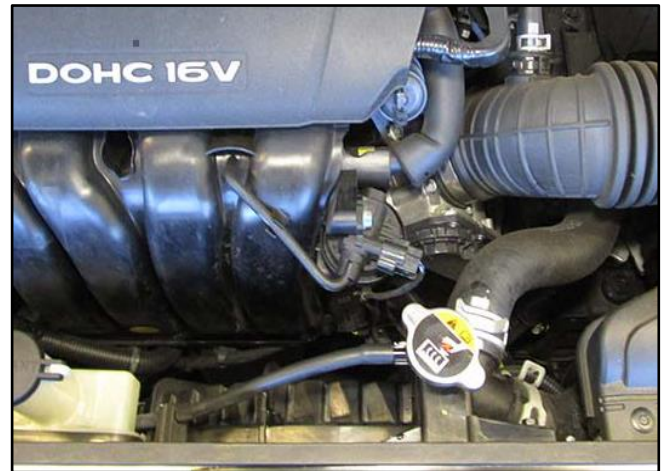
1. Open the hood and loosen the radiator cap.

DO NOT open the cap when the engine is hot.

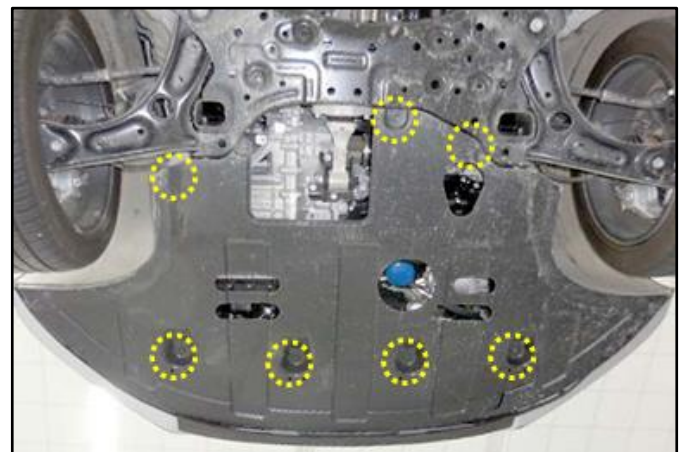
Use a 10mm socket and ratchet to remove 7 bolts as shown.

Use a trim tab or similar tool to remove 12 plastic fittings and remove the undercover.

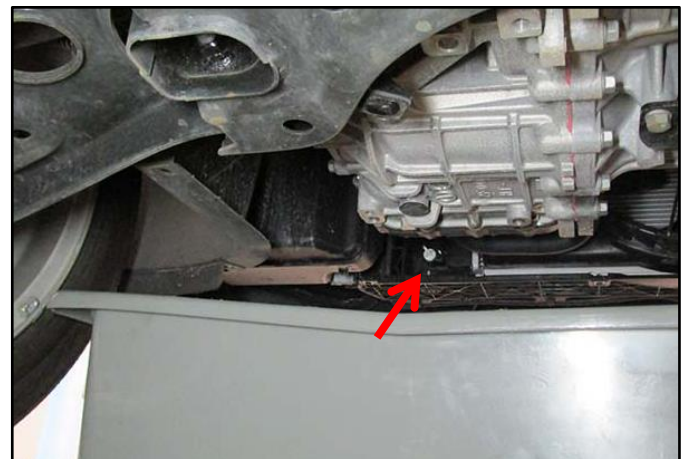
Use pliers to loosen the plastic drain plug for the radiator and drain approximately 1/2 gallon of coolant.

Tighten the plug after draining the coolant.

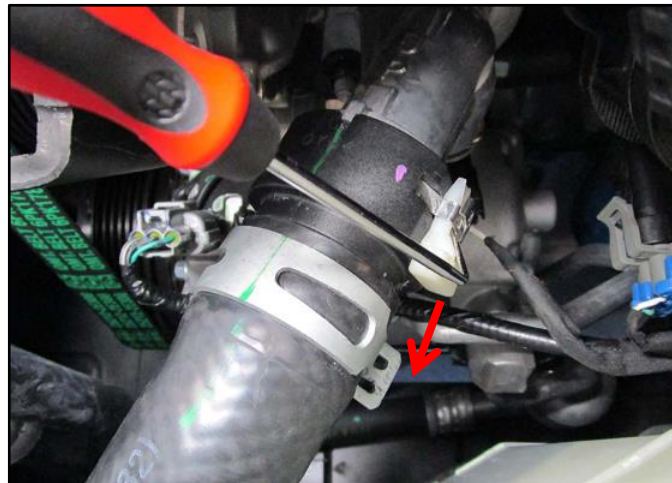
5. Locate the lower radiator hose with integral quick disconnect under the alternator.

**For vehicles with a white retainer:**

Insert a 90° pick or similar tool under the silver tab. Gently rotate the pick clockwise and lift the silver tab up. Pull the white retainer out of the tab.

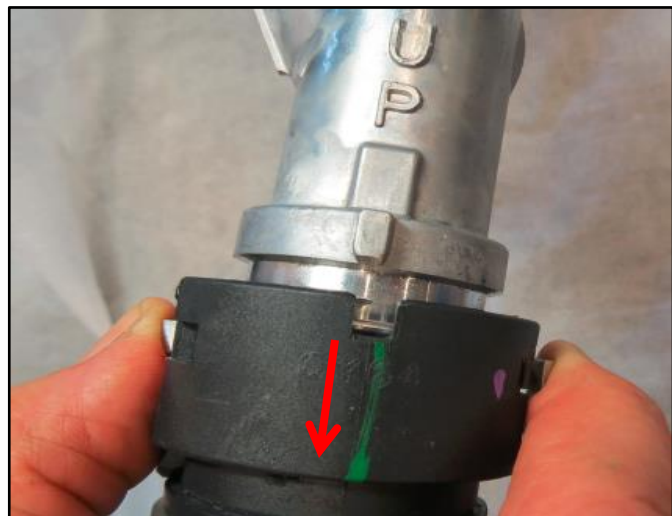
6. Press the tabs on the left and right sides of the quick disconnect and pull the radiator hose from the thermostat.

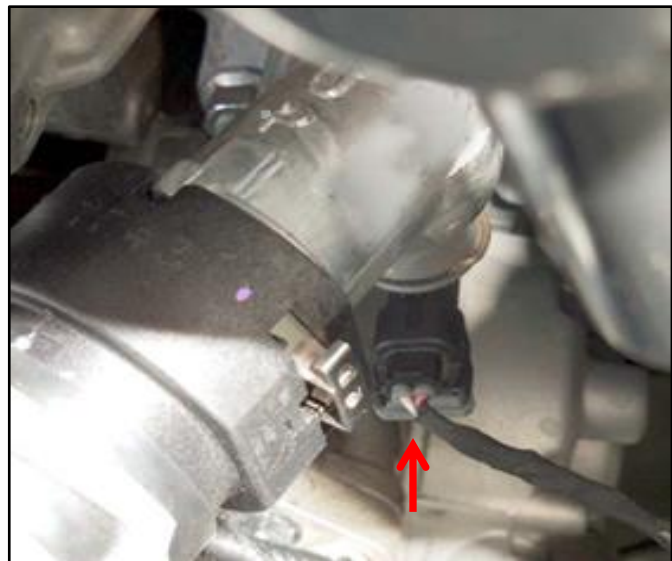
7. Press the tab on the bottom side of the coolant temperature sensor connector and disconnect the connector.

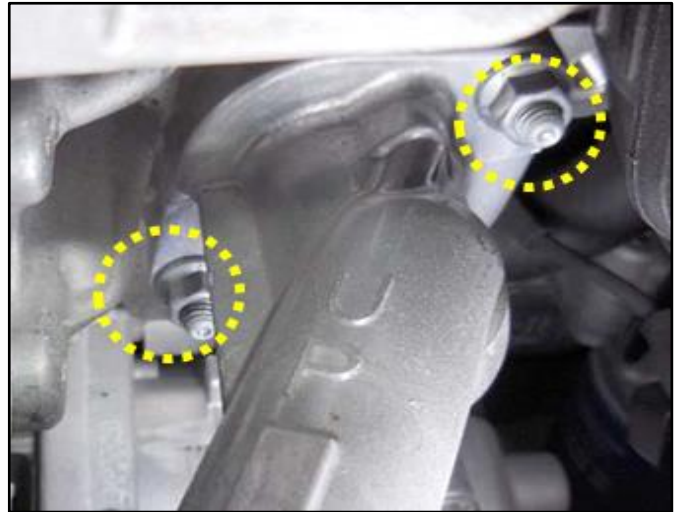
8. Use a 12mm socket and ratchet to remove the nuts for the thermostat and remove the thermostat.

Install the new thermostat and tighten the nuts to the specified torque.

**23 Nm (17 lb-ft)**

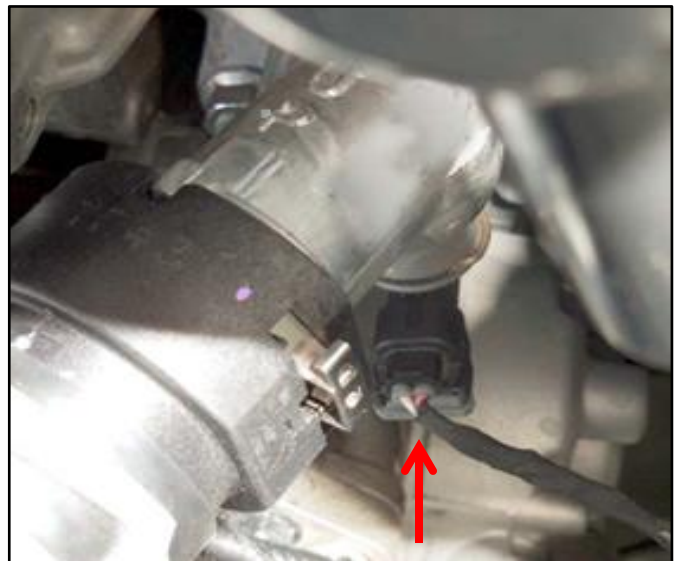
9. Reconnect the coolant temperature sensor connector.

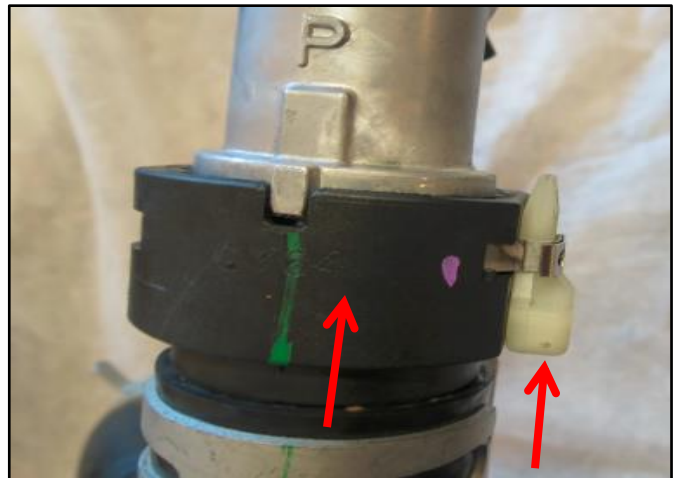
10. Reinstall the radiator hose to the thermostat.

- Push firmly until a click is heard from the quick disconnect.
- Insert the white retainer into the tab.

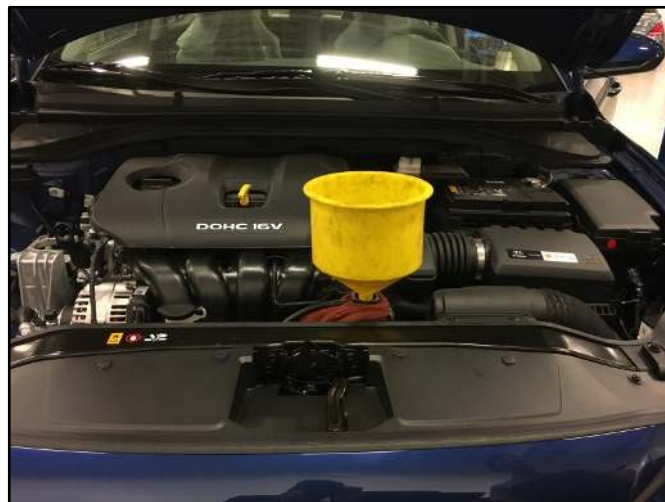
11. Refill the cooling system and prepare for air bleeding.
  - Attach a large fill funnel to the filler neck.
  - Pour the recovered coolant into the fill funnel, making sure that the coolant is clean and free of debris.
  - Keep the funnel filled to 1/3 level during the air bleeding process.

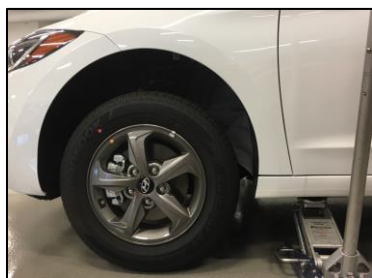
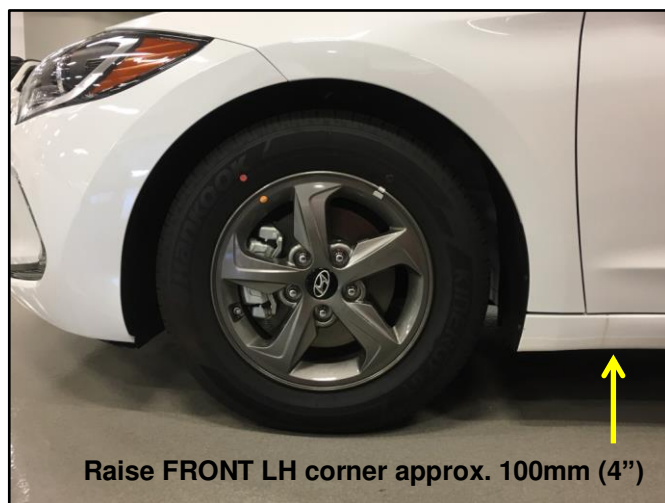
12. Elevate the FRONT LH corner of the vehicle.
  - Park vehicle on level ground with parking brake ON, and block the rear wheels.
  - Raise the front left side of the vehicle at the lift point approximately 100mm (4 inches) higher than the rest of the vehicle.

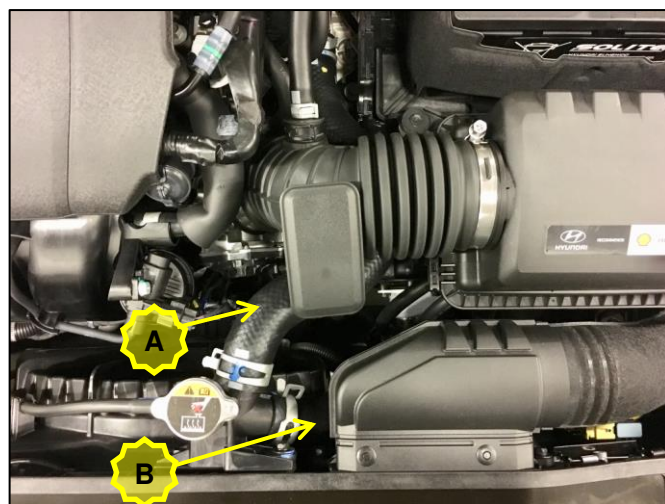
13. Gently squeeze the 2 upper radiator hoses leading to the filler neck Y-Junction several times to initially release any trapped air.
  - Hose (A) leading towards the engine
  - Hose (B) leading towards the radiator

(Fill funnel not shown in this picture only for visual purposes.) **Keep the funnel attached to the filler neck and partially filled with coolant until all air bleeding steps are complete.**

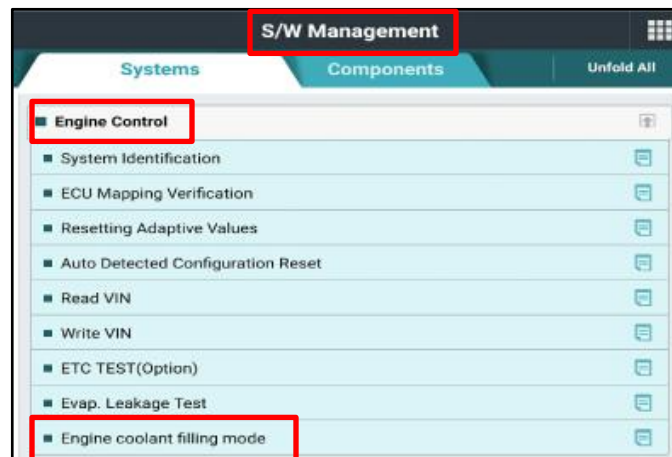
15. Attach a GDS to perform the coolant air bleeding once the minimum engine coolant temperature of 75°C (167°F) has been reached.

- From the GDS home page, Select VIN > **Software Management > Engine Control > Engine coolant filling mode.**
- Follow the prompts on the GDS to begin the air bleeding process of opening the electric thermostat, and then perform the Engine REV steps below.

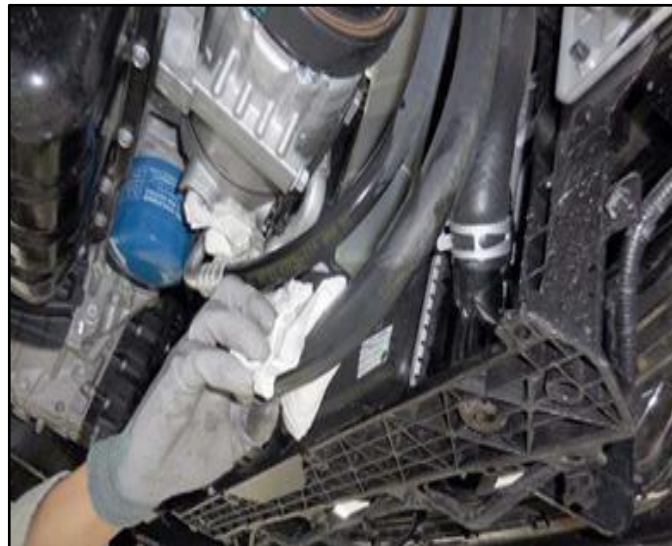
19. Clean any coolant residue under the engine.

Check for leaks from the thermostat.

Reinstall the undercover.

**5 Nm (44 lb-in)**
